CONDITION REPORT

Report No:
2017306890
DATE
05/10/2026

Vehicle Type	PASSENGER VEHICLE	Registered Owner	MFC
Manufacturer	HAVAL	Registration Number	KWN976MP
Model	H6 2.0T SUPER LUXURY AWD DCT [2021-2025]	Register Number	
		Date Of First Licensing	
VIN	LGWFF6A5XPH923711	Last COR	
Engine Number		License Expiry Date	31/07/2026
Doors	5	Power / Displacement	
Color	WHITE	Paint Finish	M - METALLIC
Year Model	2023	Fuel	PETROL
Km Reading	87,616 KM	Transmission	AUTOMATIC
Cab / Body Type	STATION WAGON

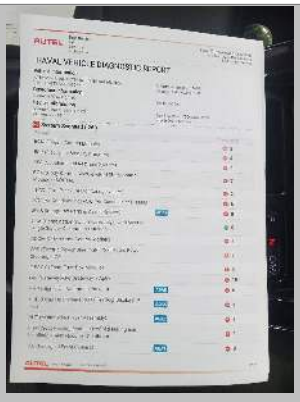
Diagnostic Report page 1

During the diagnostic the following error messages were detected: (See also attached Diagnostic Report. For more information regarding the Fault Codes (DTC) and the recommended rectifications please contact the workshops of the vehicle manufacture).

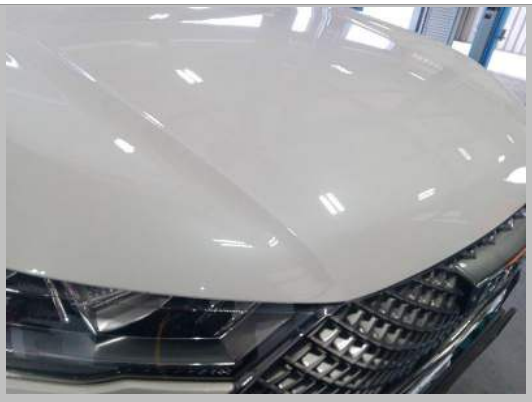
Damage	Repair Way
Front Bumper Paintwork • Chipmarks	Repair
Bonnet Paintwork • Chipmarks	Repair
Rear Fender Right Paintwork • Scratched	Repair
Door Front Left Paintwork • Scratched	Repair
Door Front Right Paintwork • Scratched	Repair
Door Rear Left Dented	Repair
Door Rear Right Dented	Repair
Engine light illuminated	Repair
