CONDITION REPORT

Report No:
2017317439
DATE
26/10/2026

Vehicle Type	PASSENGER VEHICLE	Registered Owner	MFC
Manufacturer	KIA	Registration Number	FYR158L
Model	PEGAS	Register Number	
VIN	LJD0AA29LP0203372	Date Of First Licensing	
Engine Number		Last COR	
Doors	4	License Expiry Date	28/02/2027
Color	GREY	Power / Displacement	
Year Model		Paint Finish	M - METALLIC
Km Reading	84,663 KM	Fuel	PETROL
Cab / Body Type	SEDAN	Transmission	MANUAL

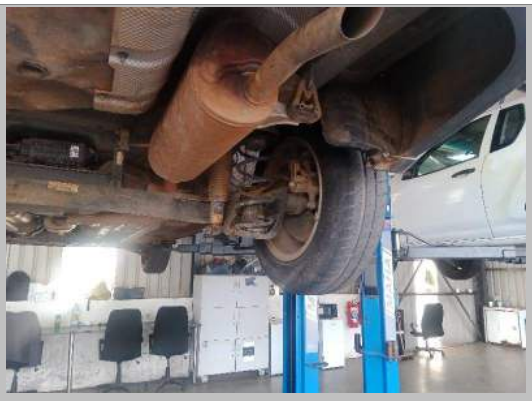
LF TYRE TREAD

Size	Load/Speed Index	Manufacture	Model	Type*	Production Date	Tread Depth (mm)
Front Left	175/70R14	84T	Nexen	N priz	V	3622	0 mm
Front Right	175/65R14	82H	Gt radial	Champiro	V	2822	2 mm
Rear Left	165/80R14	85T	Apollo	Amazer	V	3322	0 mm
Rear Right	175/70R14	84T	Goodyear	Efficient gr	V	4317	1 mm
Spare	T115/70R14	90M	Chao yang	Temporary	V	2822	3 mm

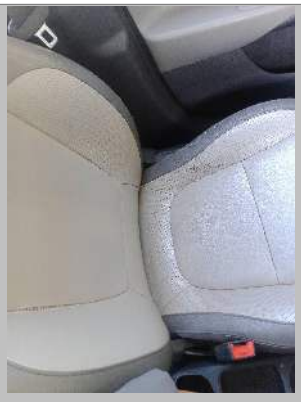
Damage	Repair Way
Seat Front Left Torn / Cut	Repair
Seat Front Right Torn / Cut	Repair
Side Mirror Left Paintwork • Scratched	Repair
Front Bumper Damaged	Repair
Bonnet Dented	Repair
Front Fender Left Paintwork • Scratched	Repair
Rear Fender Left Dented	Repair
Rear Fender Right Paintwork • Scratched	Repair
Door Front Left Paintwork • Scratched	Repair
Door Front Right Dented	Repair
Door Rear Left Paintwork • Scratched	Repair
Door Rear Right Paintwork • Scratched	Repair
Boot Lid / Hatch door Paintwork • Scratched	Repair
Rear bumper Paintwork • Scratched	Repair
Windscreen Cracked	Replace
Tyre Front Left Damaged	Replace
Tyre Rear Left Damaged	Replace
Rear and Front tyres size differs	Replace
