CONDITION REPORT

Report No:
2017312595
DATE
15/10/2026

Vehicle Type	PASSENGER VEHICLE	Registered Owner	MFC
Manufacturer	CHERY	Registration Number	KND309MP
Model	TIGGO 8PRO	Register Number	
VIN	LVTDB21B8ND043376	Date Of First Licensing	
Engine Number		Last COR	
Doors	5	License Expiry Date	30/04/2027
Color	GREY	Power / Displacement	
Year Model		Paint Finish	TWO COAT METALLIC
Km Reading	67,705 KM	Fuel	PETROL
Cab / Body Type	SUV	Transmission	AUTOMATIC

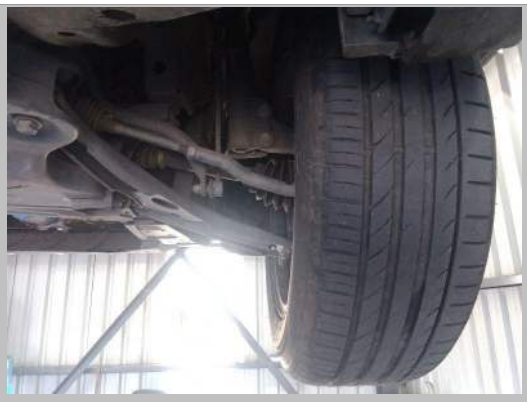
RF TYRE TREAD

Size	Load/Speed Index	Manufacture	Model	Type*	Production Date	Tread Depth (mm)
Front Left	235/55ZR18	104W	oadking	Argos	V	0425	3 mm
Front Right	235/55ZR18	108W	Oadking	Argos	V	0725	3 mm
Rear Left	235/55ZR18	104W	oadking	Argos	V	0425	3 mm
Rear Right	235/55ZR18	104W	oadking	Argos	V	0425	3 mm
Spare	T125/80D17	99M	Westlake	Temporarily	V	0000	2 mm
