CONDITION REPORT

Report No:
2017316344
DATE
23/10/2026

Vehicle Type	PASSENGER VEHICLE	Registered Owner	MFC AUCTION HOUSE
Manufacturer	CHERY	Registration Number	LKH788MP
Model	TIGGO 4 PRO 1.5 LIT [2023-ON]	Register Number	
VIN	LVVDB11B2SC119709	Date Of First Licensing	
Engine Number		Last COR	
Doors	5	License Expiry Date	30/09/2026
Color	GREY	Power / Displacement	
Year Model	2025	Paint Finish	TWO COAT UNI
Km Reading	24,017 KM	Fuel	PETROL
Cab / Body Type	STATION WAGON	Transmission	MANUAL

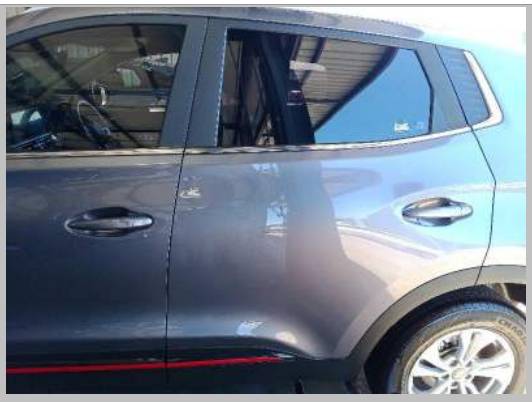
Damage	Repair Way
Fog Light Front Right Defective	Repair
Front Bumper Paintwork • Scratched	Repair
Bonnet Dented	Repair
Door Rear Left Dented	Repair
Door Rear Right Dented	Repair
Windscreen Cracked	Replace
Deceleration parking brake defective	Repair
