CONDITION REPORT

Report No:
2017315644
DATE
22/10/2026

Vehicle Type	PASSENGER VEHICLE	Registered Owner	MFC AUCTION HOUSE
Manufacturer	CHERY	Registration Number	MF89YZGP
Model	TIGGO 4 PRO 1.5 LIT [2023-ON]	Register Number	
VIN	LVVDB11B9RC111357	Date Of First Licensing	
Engine Number		Last COR	
Doors	5	License Expiry Date	28/02/2027
Color	WHITE	Power / Displacement	
Year Model	2025	Paint Finish	C - COMMON
Km Reading	38,363 KM	Fuel	PETROL
Cab / Body Type	STATION WAGON	Transmission	MANUAL

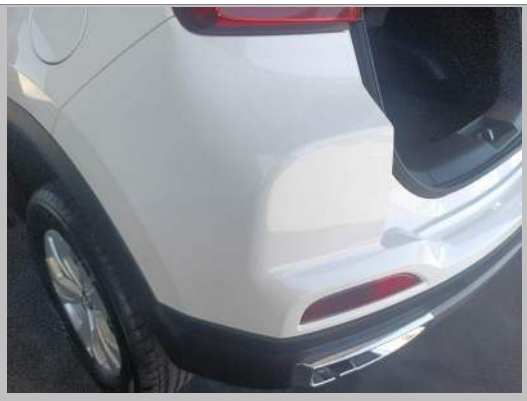
Rear bumper
