CONDITION REPORT

Report No:
2017316055
DATE
22/10/2026

Vehicle Type	PASSENGER VEHICLE	Registered Owner	MFC AUCTION HOUSE
Manufacturer	CHERY	Registration Number	HFL044L
Model	TIGGO 4 PRO 1.5 COMFORT CVT [2022-2026]	Register Number	
VIN	LVVDB21B3PD975723	Date Of First Licensing	
Engine Number		Last COR	
Doors	5	License Expiry Date	31/08/2027
Color	SILVER	Power / Displacement	
Year Model	2023	Paint Finish	C - COMMON
Km Reading	59,655 KM	Fuel	PETROL
Cab / Body Type	STATION WAGON	Transmission	AUTOMATIC

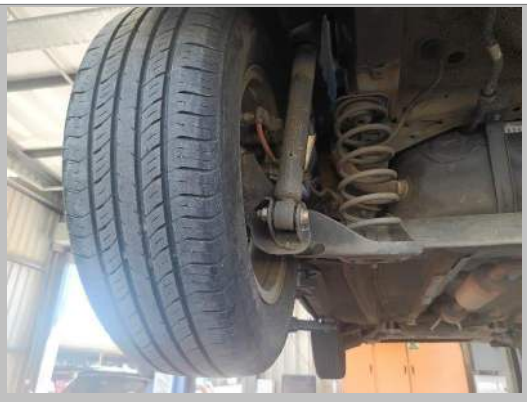
LR TYRE TREAD

Size	Load/Speed Index	Manufacture	Model	Type*	Production Date	Tread Depth (mm)
Front Left	215/65R16	98H	CHAO YANG	SU318a H/T	V	1723	4 mm
Front Right	215/65R16	98H	CHAO YANG	SU318a H/T	V	1723	4 mm
Rear Left	215/65R16	98H	CHAO YANG	SU1318a H/T	V	1723	4 mm
Rear Right	215/65R16	98H	CHAO YANG	SU318a	V	1723	4 mm
Spare	T125/80D17	99m	Westlake	temporary T5	V	////	6 mm

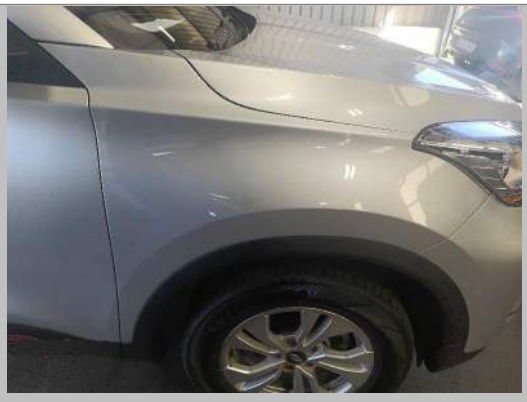
Damage	Repair Way
Side Mirror Right Paintwork • Flaking	Repair
Front Bumper Paintwork • Scratched	Repair
Bonnet Dented	Repair
Front Fender Right Dented	Repair
Door Front Right Paintwork • Scratched	Repair
Door Rear Right Dented	Repair
Body exterior	Traces dents and scratches on body panels
