CONDITION REPORT

Report No:
2017314868
DATE
21/10/2026

Vehicle Type	PASSENGER VEHICLE	Registered Owner	MFC
Manufacturer	MAHINDRA	Registration Number	LR83GRGP
Model	XUV 700	Register Number	
VIN	MA1NF2ZFFP6B78473	Date Of First Licensing	
Engine Number		Last COR	
Doors	5	License Expiry Date	30/06/2027
Color	WHITE	Power / Displacement	
Year Model		Paint Finish	TWO COAT UNI
Km Reading	53,032 KM	Fuel	PETROL
Cab / Body Type	SUV	Transmission	AUTOMATIC

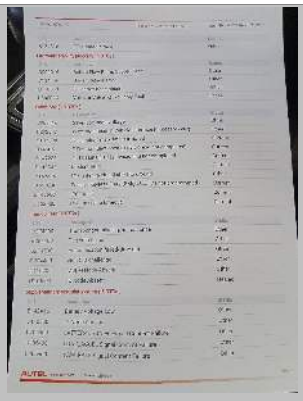
Diagnostic.

No	System	Code	Description	Status
1	MAHINDRA BODY FUNCTION MODEL	B110016	ECM UNDERVOLTAGE

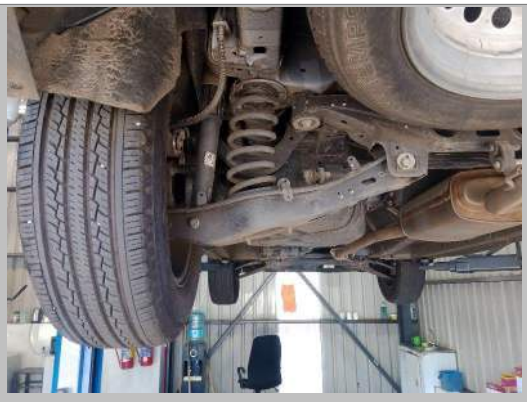
LR TYRE TREAD

Size	Load/Speed Index	Manufacture	Model	Type*	Production Date	Tread Depth (mm)
Front Left	235/65R17	108H	Rapid	Radial	V	2523	0 mm
Front Right	235/65R17	104R	MRF	Radial	V	0223	2 mm
Rear Left	235/65R17	108H	Rapid	Radial	V	0123	4 mm
Rear Right	235/65R17	104H	MRF	Radial	V	0223	3 mm
Spare	T155/90R18	113H	Gritte	Temporary	V	0000	2 mm
