CONDITION REPORT

Report No:
2017317452
DATE
27/10/2026

Vehicle Type	LIGHT LOAD VEHICLE	Registered Owner	MFC
Manufacturer	MAHINDRA	Registration Number	HPV011L
Model	SCORPIO PIK-UP 2.2 MHAWK S4 DSL [2017-ON]	Register Number	
		Date Of First Licensing	
VIN	MA1RA2CY2T2036361	Last COR	
Engine Number		License Expiry Date	31/05/2027
Doors	2	Power / Displacement	
Color	WHITE	Paint Finish	TWO COAT UNI
Year Model	2026	Fuel	DIESEL
Km Reading	7,051 KM	Transmission	MANUAL
Cab / Body Type	SINGLE CAB

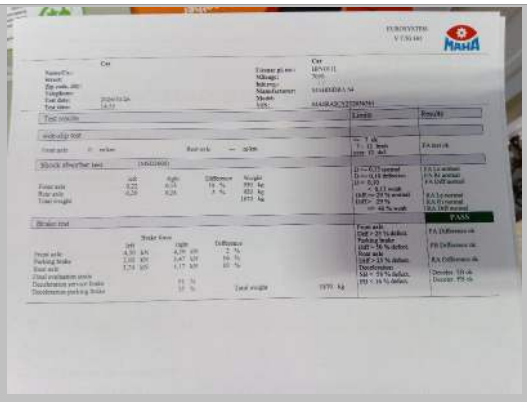
Brake test.

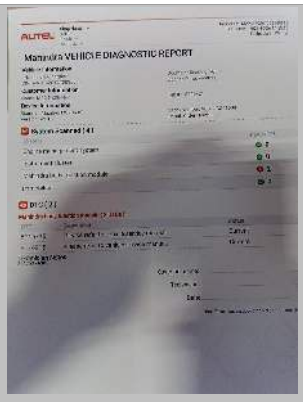
Diagnostic.

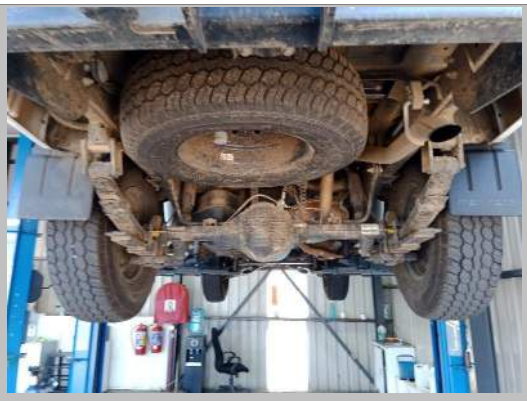
Undercarriage rear.
