CONDITION REPORT

Report No:
2017314703
DATE
20/10/2026

Vehicle Type	LIGHT LOAD VEHICLE	Registered Owner	MFC AUCTION HOUSE
Manufacturer	MAHINDRA	Registration Number	LH86RCGP
Model	SCORPIO PIK-UP 2.2 MHAWK S4 DSL [2017-ON]	Register Number	
		Date Of First Licensing	
VIN	MA1RA2VK2P2F21345	Last COR	
Engine Number		License Expiry Date	
Doors	2	Power / Displacement	
Color	WHITE	Paint Finish	C - COMMON
Year Model	2023	Fuel	DIESEL
Km Reading	42,160 KM	Transmission	MANUAL
Cab / Body Type	SINGLE CAB

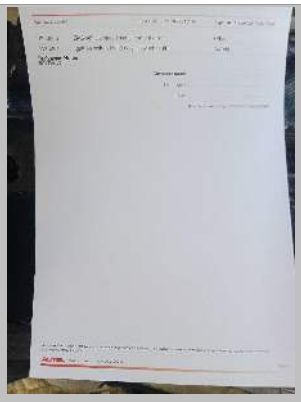
DIAGNOSTIC REPORT PAGE 1

No	System	Code	Description	Status
1	OTHER	U140100	EMS MESSAGE CONTENT FAILURE

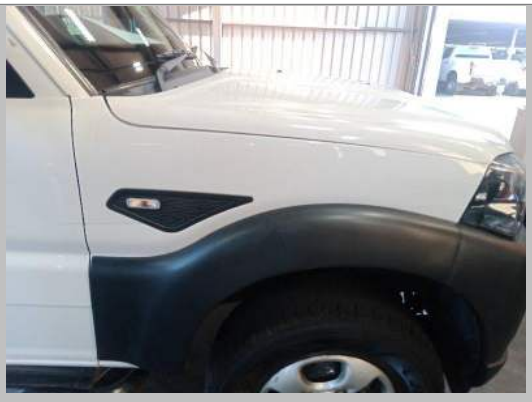
Damage	Repair Way
Tail Light Left Damaged	Replace
Tail Light Right Damaged	Replace
Fog Light Front Left Malfunction	Repair
Seat Front Left Damaged	Repair
Seat Front Right Damaged	Repair
Window Winder front right Malfunction	Repair
Side Mirror Left Damaged	Repair
Side Mirror Right Paintwork • Scratched	Repair
Bonnet Dented	Repair
B • Pillar Left Paintwork • Scratched	Repair
B • Pillar Right Dented	Repair
Front Fender Right Paintwork • Scratched	Repair
Rear Fender Left Paintwork • Scratched	Repair
Rear Fender Right Dented	Repair
Door Front Left Paintwork • Scratched	Repair
Door Front Right Paintwork • Scratched	Repair
Tailgate Paintwork • Scratched	Repair
Rear bumper Damaged	Repair
Windscreen Cracked	Replace
No license disc	Replace
L/F A piller inner panel missing	Replace
