CONDITION REPORT

Report No:
2017315317
DATE
21/10/2026

Vehicle Type	LIGHT LOAD VEHICLE	Registered Owner	
Manufacturer	MAHINDRA	Registration Number	MS03GWGP
Model	SCORPIO PIK-UP 2.2 MHAWK S6 DSL D-CAB [2020-ON]	Register Number	
		Date Of First Licensing	
VIN	MA1RC2CY2T2031709	Last COR	
Engine Number		License Expiry Date	31/10/2026
Doors	4	Power / Displacement	
Color	WHITE	Paint Finish	TWO COAT UNI
Year Model	2025	Fuel	DIESEL
Km Reading	38,255 KM	Transmission	MANUAL
Cab / Body Type	DOUBLE CAB

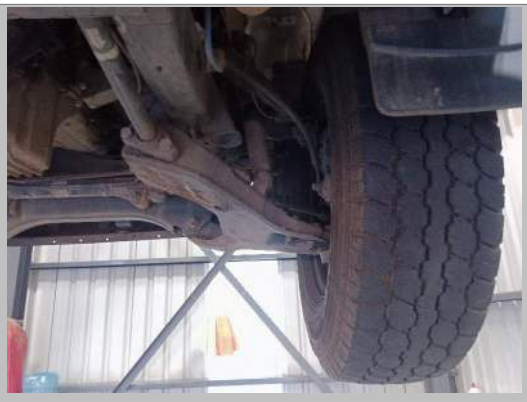
LF TYRE TREAD

Size	Load/Speed Index	Manufacture	Model	Type*	Production Date	Tread Depth (mm)
Front Left	245/75R16	111S	JKTyre	Radial	V	3225	3 mm
Front Right	245/75R16	111S	JKTyre	Radial	V	3225	3 mm
Rear Left	245/75R16	111S	JKTyre	Radial	V	3325	3 mm
Rear Right	245/75R16	111S	JKTyre	Radial	V	3225	3 mm
Spare	245/75R16	111S	JKTyre	Radial	V	0000	5 mm

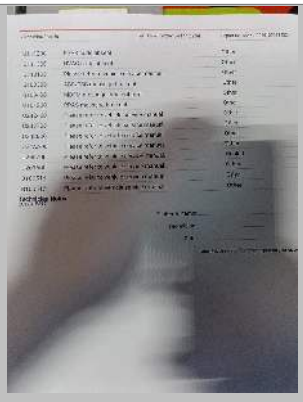
Diagnostic.

No	System	Code	Description	Status
1	INFOTAINMENT SYSTEM (21 DTCS)	U130100	VIN MISMATCH IN IS

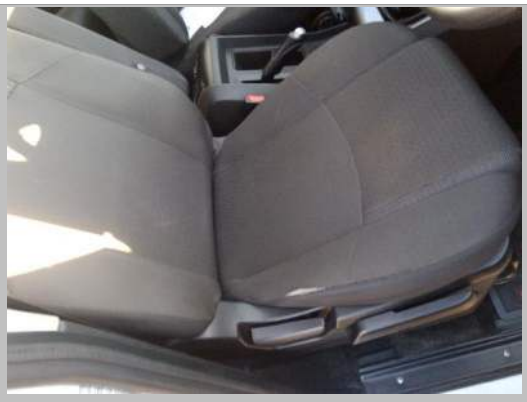
Damage	Repair Way
Engine Oil Leak	Repair
Seat Front Right Damaged	Repair
Front Bumper Damaged	Repair
Bonnet Damaged	Repair
Front Fender Left Damaged	Repair
Front Fender Right Damaged	Repair
Rear Fender Left Damaged	Repair
Rear Fender Right Damaged	Repair
Door Front Left Damaged	Repair
Tailgate Damaged	Repair
Rear bumper Damaged	Repair
Windscreen Damaged	Replace
Gearbox Oil Leak	Replace
