CONDITION REPORT

Report No:
2017319162
DATE
29/10/2026

Vehicle Type	PASSENGER VEHICLE	Registered Owner	MFC AUCTION HOUSE
Manufacturer	SUZUKI	Registration Number	MJ47JFGP
Model	ERTIGA 1.5 GL MPV [2022-2025]	Register Number	
VIN	MA3BNC22S00A20759	Date Of First Licensing	
Engine Number		Last COR	
Doors	5	License Expiry Date	31/07/2027
Color	SILVER	Power / Displacement	
Year Model	2025	Paint Finish	TWO COAT METALLIC
Km Reading	155,270 KM	Fuel	PETROL
Cab / Body Type	STATION WAGON	Transmission	MANUAL

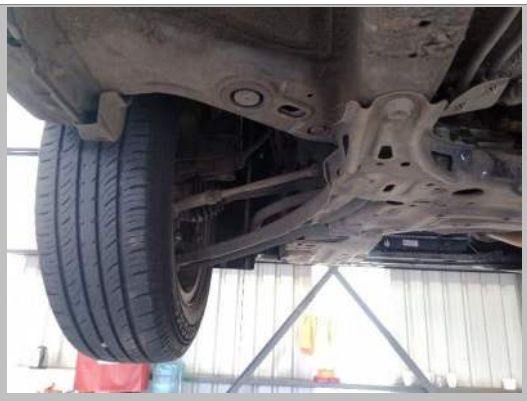
Undercarriage front.

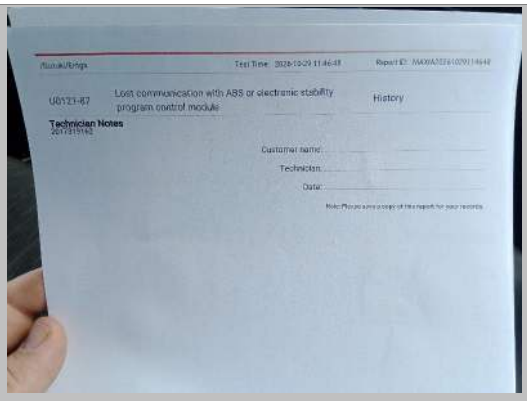
Diagnostic.

No	System	Code	Description	Status
1	ABS/ESP	U0126	LAST COMMUNICATION WITH STEERING ANGLE SENSOR MODU

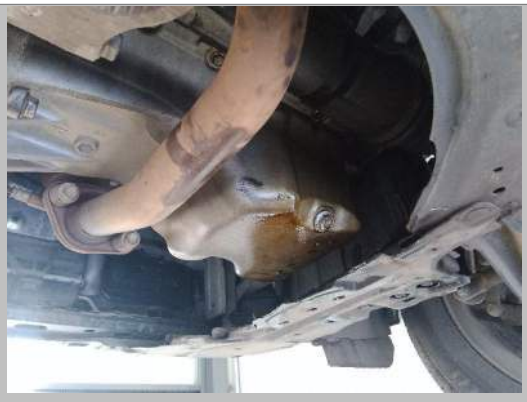
Damage	Repair Way
Engine Oil Leak	Repair
Central Air Vent Damaged	Repair
Front Bumper Damaged	Repair
Bonnet Damaged	
Front Fender Right Damaged	Repair
Rear Fender Right Damaged	Repair
Door Front Left Damaged	Repair
Door Front Right Damaged	Repair
Door Rear Left Damaged	Repair
Door Rear Right Damaged	Repair
