CONDITION REPORT

Report No:
2017316616
DATE
26/10/2026

Vehicle Type	PASSENGER VEHICLE	Registered Owner	MFC
Manufacturer	SUZUKI	Registration Number	KSZ372MP
Model	S-PRESSO 1.0 GL+ MT [2022-ON]	Register Number	
VIN	MA3RFL61S00412813	Date Of First Licensing	
Engine Number		Last COR	
Doors	5	License Expiry Date	
Color	GREY	Power / Displacement	
Year Model	2023	Paint Finish	M - METALLIC
Km Reading	64,154 KM	Fuel	PETROL
Cab / Body Type	HATCHBACK	Transmission	MANUAL

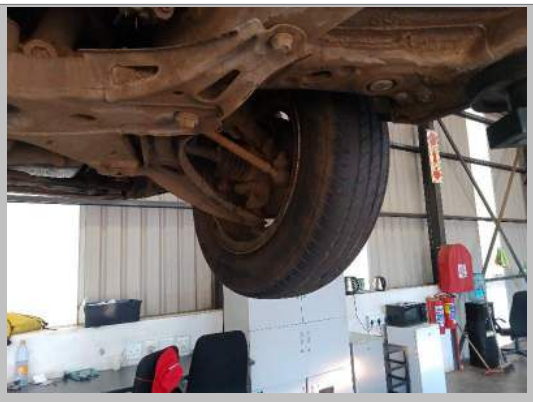
RR TYRE TREAD

Size	Load/Speed Index	Manufacture	Model	Type*	Production Date	Tread Depth (mm)
Front Left	165/70R14	81S	MRF	Zvtv	V	3622	2 mm
Front Right	165/70R14	81S	MRF	Zvtv	V	3622	0 mm
Rear Left	165/70R14	81S	MRF	Zvtv	V	3622	3 mm
Rear Right	165/70R14	81S	MRF	Zvtv	V	3622	2 mm

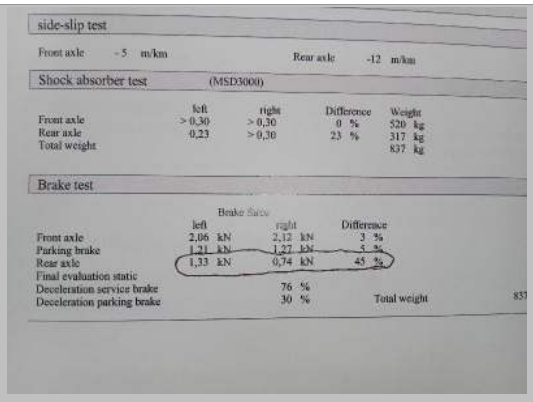
Damage	Repair Way
Engine Oil Sweat	Repair
Boot Carpet Missing	Replace
Front Bumper Paintwork • Scratched	Repair
Bonnet Paintwork • Scratched	Repair
Front Fender Left Paintwork • Scratched	Repair
Front Fender Right Paintwork • Scratched	Repair
Rear Fender Left Dented	Repair
Rear Fender Right Paintwork • Scratched	Repair
Door Front Left Dented	Repair
Door Front Right Dented	Repair
Door Rear Left Paintwork • Scratched	Repair
Door Rear Right Paintwork • Scratched	Repair
Boot Lid / Hatch door Dented	Repair
Rear bumper Paintwork • Scratched	Repair
Windscreen Cracked	Replace
Window Front Door Left Damaged	Replace
Back Window Damaged	Replace
Service Brake Performance Rear Axle Left / Right Difference out of legal range	Repair
Tyre Front Right Damaged	Replace
Gearbox Oil Leak	Repair
No license disc	Replace
