CONDITION REPORT

Report No:
2017313400
DATE
16/10/2026

Vehicle Type	PASSENGER VEHICLE	Registered Owner	MFC AUCTION HOUSE
Manufacturer	SUZUKI	Registration Number	MC94DBGP
Model	CELERIO 1.0 GL 5-DR [2022-ON]	Register Number	
VIN	MA3TFC62S00316127	Date Of First Licensing	
Engine Number		Last COR	
Doors	5	License Expiry Date	
Color	GREY	Power / Displacement	
Year Model	2025	Paint Finish	M - METALLIC
Km Reading	176,963 KM	Fuel	PETROL
Cab / Body Type	HATCHBACK	Transmission	MANUAL

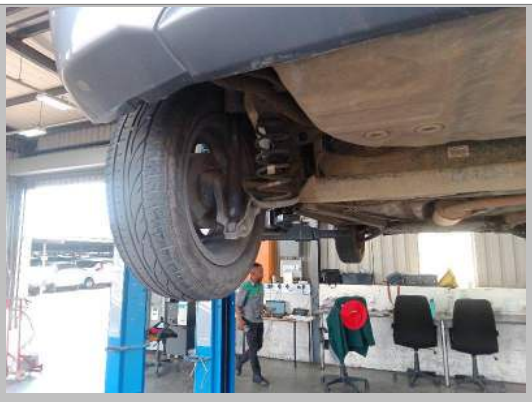
LF TYRE TREAD

Size	Load/Speed Index	Manufacture	Model	Type*	Production Date	Tread Depth (mm)
Front Left	175/60R15	81H	Yokohama	Bluearth	V	3325	3 mm
Front Right	175/60R15	81T	Yokohama	Bluearth	V	3325	3 mm
Rear Left	175/65R15	88H	Radar	RPX -800	V	1125	3 mm
Rear Right	175/60R15	81H	Yokohama	Bluearth	V	2523	3 mm
Spare	165/70R14	81S	Bridgestone	Ecopia	V	3824	4 mm
