CONDITION REPORT

Report No:
2017326414
DATE
17/11/2026

Vehicle Type	PASSENGER VEHICLE	Registered Owner	
Manufacturer	FORD	Registration Number	MN77YXGP
Model	ECOSPORT 1.0 ECOBOOST TREND [2013-2014]	Register Number	
VIN	MAJAXXMRKADE10048	Date Of First Licensing	
Engine Number		Last COR	
Doors	5	License Expiry Date	
Color	GREEN	Power / Displacement	
Year Model	2014	Paint Finish	PEARL EFFECT
Km Reading	180,585 KM	Fuel	PETROL
Cab / Body Type	HATCHBACK	Transmission	MANUAL

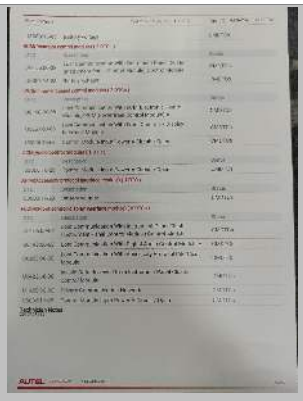
Diagnostics

During the diagnostic the following error messages were detected: (See also attached Diagnostic Report. For more information regarding the Fault Codes (DTC) and the recommended rectifications please contact the workshops of the vehicle manufacture).

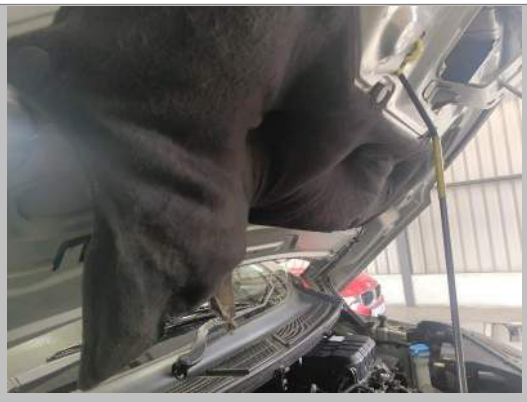
Damage	Repair Way
Under bonnet insulation cover Defective	Replace
Tail Light Left Defective	Repair
Tail Light Right Cracked	Replace
Headlight Left Cracked	Replace
Headlight Right Damaged	Replace
Door Lock Front Right Defective	Repair
Front Bumper Paintwork • Chipmarks	Repair
Bonnet Paintwork • Chipmarks	Repair
Front Fender Left Paintwork • Chipmarks	Repair
Front Fender Right Dented	Repair
Rear Fender Left Dented	Repair
Rear Fender Right Damaged	Repair
Front Fender Right / Inner Tray Damaged	Replace
Door Front Left Paintwork • Chipmarks	Repair
Door Front Right Dented	Repair
Door Rear Left Dented	Repair
Door Rear Right Dented	Repair
Roof Dented	Repair
Windscreen Chipped	Repair
Tie Rod End right Damaged	Replace
Rebound Rubber Rear Axle Left Damaged	Replace
Rebound Rubber Rear Axle Right Damaged	Replace
Ball Joint(s) Front Axle Left Damaged	Replace
Ball Joint(s) Front Axle Right Damaged	Replace
Radiator Cradle Cracked	Replace
