CONDITION REPORT

Report No:
2017309138
DATE
08/10/2026

Vehicle Type	PASSENGER VEHICLE	Registered Owner	MFC
Manufacturer	FORD	Registration Number	KPY852MP
Model	ECOSPORT 1.5 TITANIUM POWERSHIFT [2014-2016]	Register Number	
		Date Of First Licensing	
VIN	MAJAXXMRKAEA53612	Last COR	
Engine Number		License Expiry Date	
Doors	5	Power / Displacement	
Color	ORANGE	Paint Finish	M - METALLIC
Year Model	2014	Fuel	PETROL
Km Reading	110,736 KM	Transmission	AUTOMATIC
Cab / Body Type	HATCHBACK

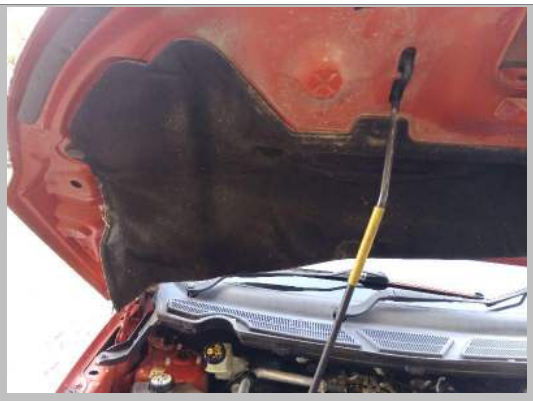
Damage	Repair Way
Under bonnet insulation cover Damaged	Repair
Windscreen Wiper Missing	Replace
Dim and Bright Indicator Light Malfunction	Repair
Fog Light Front Left Malfunction	Repair
Fog Light Front Right Malfunction	Repair
Side Mirror Left Damaged	Repair
Front Bumper Paintwork • Scratched	Repair
Bonnet Paintwork • Discoloured	Repair
Front Fender Left Paintwork • Scratched	Repair
Front Fender Right Paintwork • Scratched	Repair
Rear Fender Left Paintwork • Scratched	Repair
Rear Fender Right Paintwork • Scratched	Repair
Door Front Left Paintwork • Scratched	Repair
Door Front Right Dented	Repair
Door Rear Left Paintwork • Scratched	Repair
Door Rear Right Paintwork • Scratched	Repair
Boot Lid / Hatch door Dented	Repair
Rear bumper Paintwork • Scratched	Repair
Windscreen Chipped	Repair
Spare Tyre Damaged	Replace
Body exterior	Vehicle got minor scratches, stone chips and dents
Body exterior	Discoloring on some body panels
