CONDITION REPORT

Report No:
2017314567
DATE
20/10/2026

Vehicle Type	PASSENGER VEHICLE	Registered Owner	
Manufacturer	FORD	Registration Number	KKC804NW
Model	FIGO 1.5 AMBIENTE 5-DR [2018-2021]	Register Number	
VIN	MAJGXXMTKGKK75801	Date Of First Licensing	
Engine Number		Last COR	
Doors	5	License Expiry Date	28/02/2027
Color	WHITE	Power / Displacement	
Year Model	2019	Paint Finish	ONE COAT UNI
Km Reading	119,068 KM	Fuel	PETROL
Cab / Body Type	HATCHBACK	Transmission	MANUAL

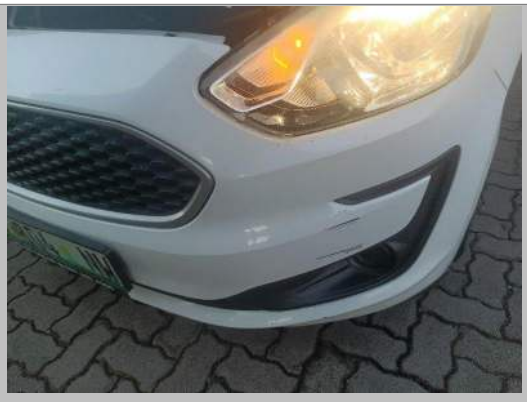
Damage	Repair Way
Fan Belt Damaged	Replace
Air conditioner pipes Damaged	Replace
Bonnet safety caps Damaged	Replace
Bonnet hinges Damaged	Repair
Headlight Left Scratched	Replace
Headlight Right Damaged	Replace
Door Sealing Rubber Rear Left Defective	Repair
Door Sealing Rubber Rear Right Defective	Repair
Front Bumper Damaged	Repair
Bonnet Damaged	Repair
Bonnet slam plate (Shock tower/ Inner tray) Damaged	Repair
Front Fender Left Damaged	Repair
Front Fender Right Damaged	Repair
Rear Fender Left Paintwork • Scratched	Repair
Rear Fender Right Paintwork • Scratched	Repair
Door Front Left Paintwork • Scratched	Repair
Door Front Right Damaged	Repair
Door Rear Left Damaged	Repair
Door Rear Right Damaged	Repair
Rear bumper Damaged	Repair
Sill Panel Right Damaged	Repair
Rocker Panel Left Dented	Repair
Windscreen Chipped	Repair
Control Arm(s) Front Axle Left Damaged	Replace
Tyre Front Left Smooth	Replace
Tyre Rear Right Damaged	Replace
