CONDITION REPORT

Report No:
2017312029
DATE
14/10/2026

Vehicle Type	PASSENGER VEHICLE	Registered Owner	MFC
Manufacturer	HONDA	Registration Number	KG67DWGP
Model	AMAZE 1.2 COMFORT [2018-2021]	Register Number	
VIN	MAKDF5510J4000073	Date Of First Licensing	
Engine Number		Last COR	
Doors	4	License Expiry Date	31/12/2026
Color	SILVER	Power / Displacement	
Year Model	2019	Paint Finish	M - METALLIC
Km Reading	190,098 KM	Fuel	PETROL
Cab / Body Type	SEDAN	Transmission	MANUAL

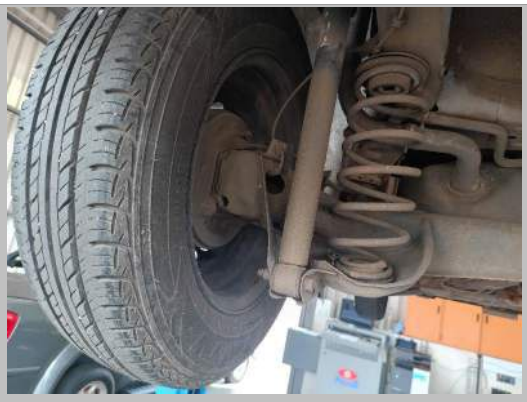
LF TYRE TREAD

LR TYRE TREAD

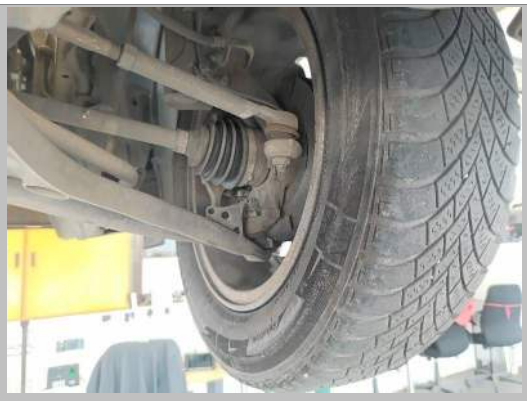
RR TYRE TREAD

RF TYRE TREAD

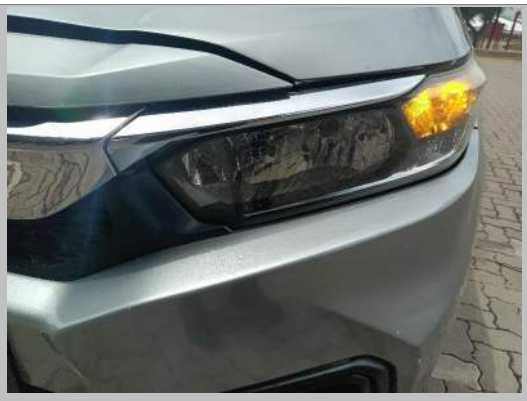
Damage	Repair Way
Tail Light Left Damaged	Replace
Tail Light Right Defective	Repair
Headlight Left Defective	Repair
Headlight Right Damaged	Replace
Seat Front Left Dirty	Repair
Seat Front Right Torn / Cut	Repair
Seat Rear Dirty	Repair
Door Handle Rear Left Damaged	Replace
Side Mirror Right Damaged	Replace
Rear Lower Valance Damaged	Repair
Front Bumper Damaged	Repair
Grill Damaged	Repair
Bonnet Residual Traces of Repair	Repair
Front Fender Left Dented	Repair
Front Fender Right Residual Traces of Repair	Repair
Rear Fender Left Paintwork • Scratched	Repair
Rear Fender Right Dented	Repair
Rear Fender Left / Inner Tray Damaged	Repair
Door Front Left Paintwork • Scratched	Repair
Door Front Right Dented	Repair
Door Rear Left Paintwork • Scratched	Repair
Door Rear Right Dented	Repair
Boot Lid / Hatch door Dented	Repair
Rear bumper Damaged	Repair
Inner Boot Floor Pan and Spare Wheel Well Damaged	Repair
Roof Dented	Repair
Parking Brake Performance Left / Right Difference out of legal range	Repair

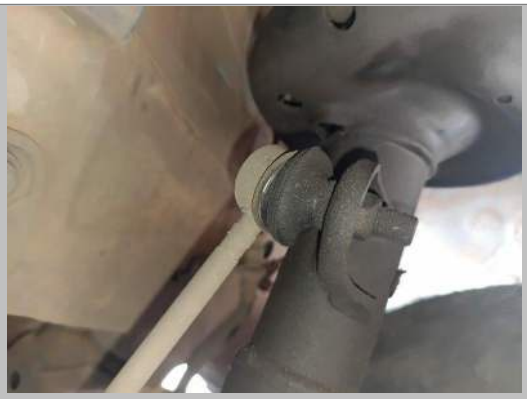
Shock Absorber Front Left Leak	Replace
Stabilizer Mounting Front Left Damaged	Replace
Wheel bearing Front Left Loose / Excessive Play	Repair
Ball Joint(s) Front Axle Right Damaged	Replace
Tyre Front Left Smooth	Replace
Tyre Rear Right Smooth	Replace
Radiator Cross Member Deformed	Repair
Warning lights illuminated	Repair
Some body panels misaligned	Repair
Bootlid does not open	Repair
Rear tyre size differs	Replace

Size	Load/Speed Index	Manufacture	Model	Type*	Production Date	Tread Depth (mm)
Front Left	185/65R15	88H	Timax	Eco comfort	V	3522	0 mm
Front Right	185/65R15	88T	Nexen	Winguard	V	4323	1 mm
Rear Left	175/70R14	84T	MRF	ZVTV	V	3418	5 mm
Rear Right	185/65R15	88H	Pirelli	All season	V	2521	0 mm
