CONDITION REPORT

Report No:
2017310690
DATE
13/10/2026

Vehicle Type	PASSENGER VEHICLE	Registered Owner	MFC
Manufacturer	HYUNDAI	Registration Number	HR41NVGP
Model	GRAND I10	Register Number	
VIN	MALA851ALJM869327	Date Of First Licensing	
Engine Number		Last COR	
Doors	5	License Expiry Date	28/02/2026
Color	GREY	Power / Displacement	
Year Model		Paint Finish	M - METALLIC
Km Reading	103,768 KM	Fuel	PETROL
Cab / Body Type	HATCHBACK	Transmission	MANUAL

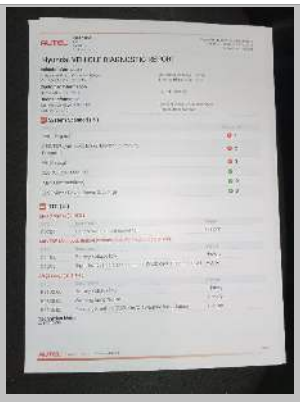
Shock and brake report

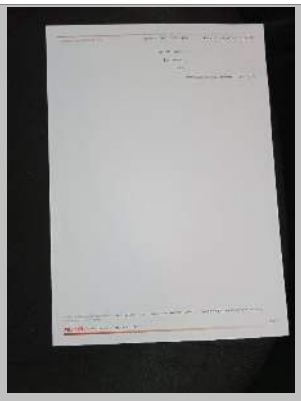
Diagnostic report

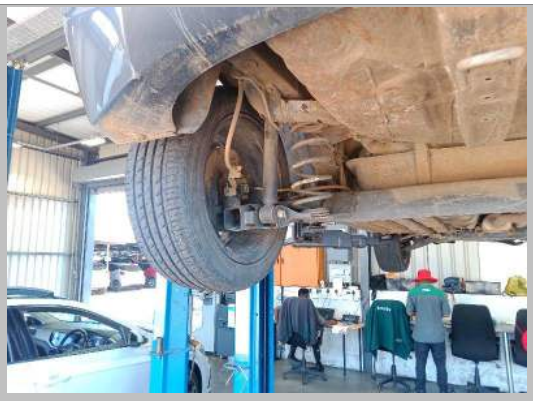
LR TYRE TREAD

Size	Load/Speed Index	Manufacture	Model	Type*	Production Date	Tread Depth (mm)
Front Left	195/50R15	82H	Rovelo	Rhp-a68	V	1724	3 mm
Front Right	195/50R15	82H	Rovelo	Rhp-a68	V	1924	3 mm
Rear Left	195/50R15	82H	Rovelo	Rhp-a68	V	1724	3 mm
Rear Right	165/65R14	79H	Nexen	Cp661	V	1318	3 mm
Spare	195/50R15	82H	Rovelo	Rhp-a68	V	3324	3 mm

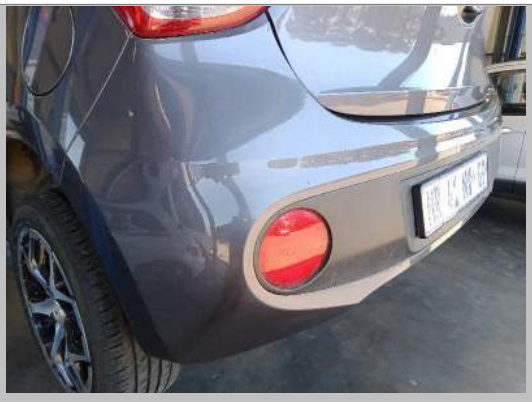
Damage	Repair Way
Side Mirror Right Paintwork • Scratched	Repair
Front Bumper Damaged	Repair
Bonnet Paintwork • Chipmarks	Repair
Front Fender Left Paintwork • Scratched	Repair
Front Fender Right Dented	Repair
Rear Fender Left Dented	Repair
Rear Fender Right Paintwork • Scratched	Repair
Door Front Left Paintwork • Scratched	Repair
Door Front Right Paintwork • Scratched	Repair
Door Rear Left Paintwork • Scratched	Repair
Door Rear Right Paintwork • Scratched	Repair
Boot Lid / Hatch door Paintwork • Scratched	Repair
Rear bumper Paintwork • Scratched	Repair
Sill Panel Left Paintwork • Scratched	Repair
Roof Dented	Repair
Spare Tyre Damaged	Replace
Rim Rear Right Dented	Repair
Rim Spare Wheel Damaged	Repair
ABS light on	Repair
Both front fender liner damage	Replace
Rear tyres size differs	Replace
