CONDITION REPORT

Report No:
2017316027
DATE
27/10/2026

Vehicle Type	PASSENGER VEHICLE	Registered Owner	MFC
Manufacturer	HYUNDAI	Registration Number	JD27TZGP
Model	GRAND I10	Register Number	
VIN	MALA851ALKM030750	Date Of First Licensing	
Engine Number		Last COR	
Doors	5	License Expiry Date	
Color	WHITE	Power / Displacement	
Year Model	2026	Paint Finish	C - COMMON
Km Reading	147,198 KM	Fuel	PETROL
Cab / Body Type	HATCHBACK	Transmission	MANUAL

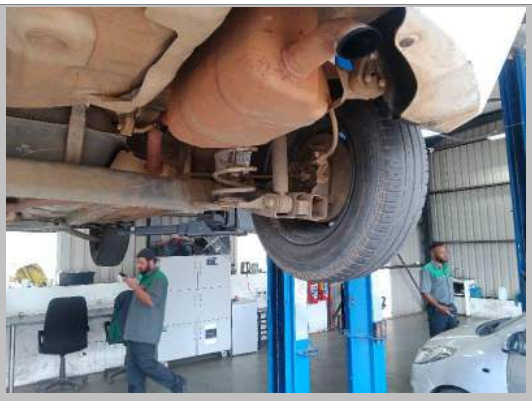
LR TYRE TREAD

Size	Load/Speed Index	Manufacture	Model	Type*	Production Date	Tread Depth (mm)
Front Left	175/65R14	82H	Sailun	Antares 86	V	3020	0 mm
Front Right	185/65R15	92T	Barum	Brilliants	V	3020	4 mm
Rear Left	175/65R14	82T	Hankook	Ventus	V	4017	0 mm
Rear Right	175/70R13	82T	Matador	Stella	V	4511	3 mm

ABS light and Boot light on	Repair
All four hup caps missing	Replace
Antenna missing	Replace
Both front fender liner damage	Replace
Boot panels missing	Replace
Rear and Front tyres size differs	Replace

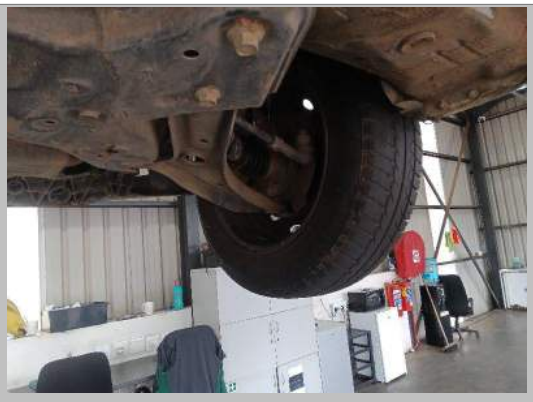
RF TYRE TREAD

No license disc
