CONDITION REPORT

Report No:
2017316060
DATE
22/10/2026

Vehicle Type	PASSENGER VEHICLE	Registered Owner	MFC AUCTION HOUSE
Manufacturer	HYUNDAI	Registration Number	KC87FXGP
Model	GRAND I10 1.25 FLUID 5-DR [2014-2017]	Register Number	
VIN	MALA851CLGM388516	Date Of First Licensing	
Engine Number		Last COR	
Doors	5	License Expiry Date	
Color	SILVER	Power / Displacement	
Year Model	2016	Paint Finish	TWO COAT UNI
Km Reading	31,056 KM	Fuel	PETROL
Cab / Body Type	HATCHBACK	Transmission	MANUAL

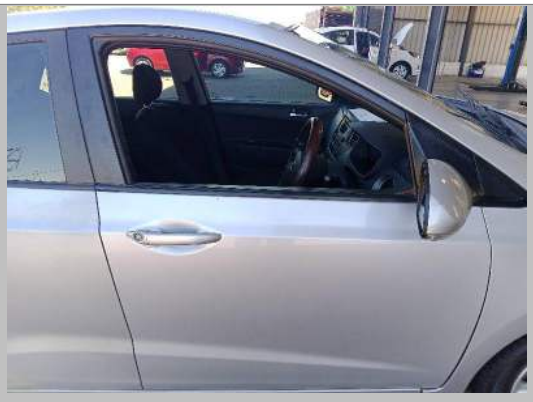
Damage	Repair Way
Engine Oil Leak	Repair
Engine Wiring Defective	Repair
Hoses Defective	Replace
Battery clamps Defective	Repair
Air cleaner Defective	Repair
Central Air Vent Defective	Repair
Switch Electrical Window Winder rear right Damaged	Replace
Windscreen Wiper Missing	Replace
Air Conditioner Insufficient	Replace
Headlight Left Defective	Repair
Headlight Right Defective	Repair
Seat Front Right Torn / Cut	Repair
Seat Rear Torn / Cut	Repair
Seat Belt Rear Left Torn / Cut	Replace
Door Sealing Rubber Front Right Damaged	Replace
Door Sealing Rubber Rear Left Damaged	Replace
Parcel Tray Damaged	Repair
Side Mirror Right Paintwork • Scratched	Repair
Front Bumper Damaged	Replace
Bonnet Paintwork • Chipmarks	Repair
Firewall Damaged	Repair
A • Pillar Left Dented	Repair
C • Pillar Left Dented	Repair
Front Fender Left Residual Traces of Repair	Repair
Front Fender Right Damaged	Repair
Rear Fender Left Damaged	Repair
Rear Fender Right Damaged	Repair

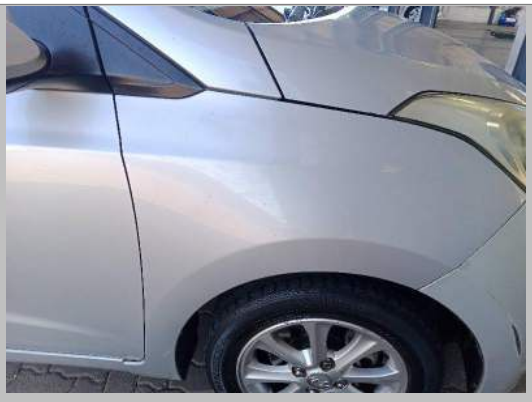
Front Fender Left / Inner Tray Damaged	Replace
Front Fender Right / Inner Tray Damaged	Replace
Door Front Right Residual Traces of Repair	Repair
Door Rear Left Paintwork • Scratched	Repair
Door Rear Right Damaged	Repair
Boot Lid / Hatch door Dented	Repair
Rear bumper Damaged	Repair
Inner Boot Floor Pan and Spare Wheel Well Dented	Repair
Sill Panel Left Damaged	Repair
Sill Panel Right Damaged	Repair
Roof Residual Traces of Repair	Repair
Stabilizer Mounting Front Right Damaged	Replace
Mounting Rubber(s) Rear Axle Left Cracked	Replace
Mounting Rubber(s) Rear Axle Right Cracked	Replace
Tyre Front Left Worn	Replace
Tyre Front Right Damaged	Replace
Tyre Rear Right Worn	Replace
Rim Front Left Scratched	Repair
Rim Front Right Scratched	Repair
Rim Rear Left Scratched	Repair
Rim Rear Right Scratched	Repair
Chassis Damaged	Repair
Sub Frame Damaged	Replace
Engine mountings Loose / Excessive Play	Repair
Belly plates Damaged	Replace

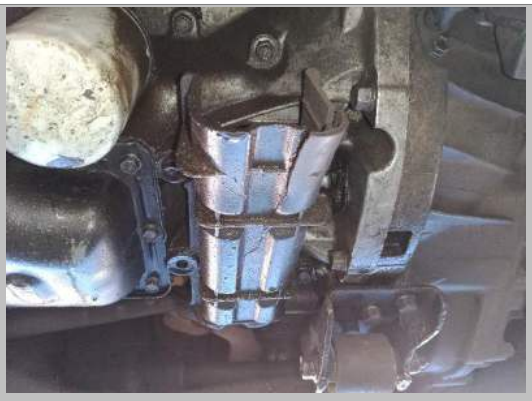
Gearbox Oil Leak	Repair
Fuel Tank Damaged	Replace
Radiator Cradle Damaged	Replace
Engine Noise Excessive	Repair
