CONDITION REPORT

Report No:
2017326167
DATE
17/11/2026

Vehicle Type	PASSENGER VEHICLE	Registered Owner	MFC
Manufacturer	HYUNDAI	Registration Number	MF67PDGP
Model	ATOS 1.1 50KW MOTION 5-DR [2019-2024]	Register Number	
VIN	MALAF51CLNM186462	Date Of First Licensing	
Engine Number		Last COR	
Doors	5	License Expiry Date	28/02/2026
Color	RED	Power / Displacement	
Year Model	2022	Paint Finish	TWO COAT METALLIC
Km Reading	105,429 KM	Fuel	PETROL
Cab / Body Type	HATCHBACK	Transmission	MANUAL

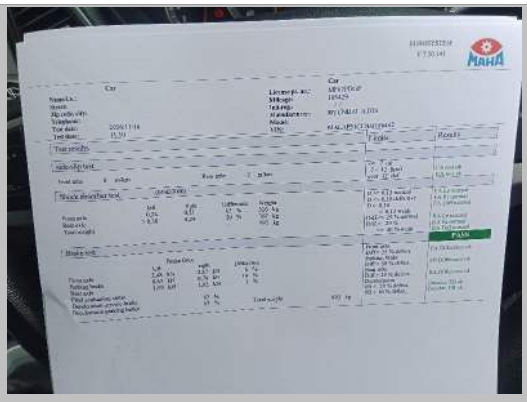
Brake test.

Left	Right		
	Braking Force [KN]	Braking Force [KN]	Axle Weight [KG]	Deceleration [m/s²]
Front	2.48	2.33	-	
Rear	1.59	1.62	-	
Emergency / Parking	0.67	0.78	-

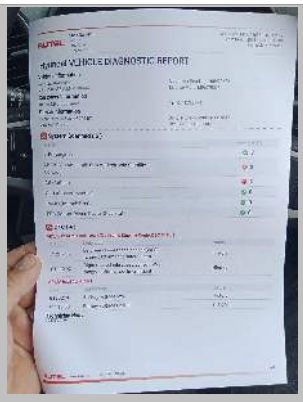
Diagnostic.

No	System	Code	Description	Status
1	ABS/ESP	C1207:02	LEFT REAR WHEEL SPEED SENSOR RANGE/PERFORMANCE/INT

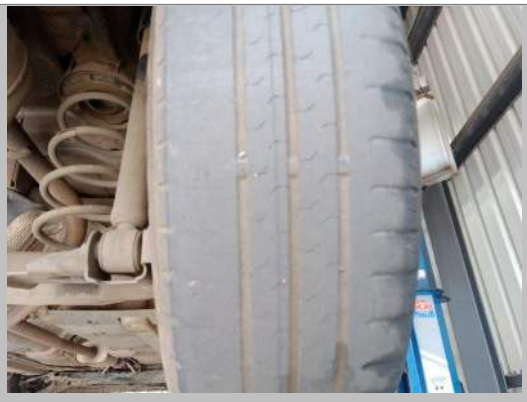
Tyre Rear Right

Size	Load/Speed Index	Manufacture	Model	Type*	Production Date	Tread Depth (mm)
Front Left	165/70R14	81T	Hankook	Radial	V	3824	2 mm
Front Right	165/70R14	81H	Hankook	Radial	V	3824	2 mm
Rear Left	165/70R14	81T	MRF	Radial	V	1022	0 mm
Rear Right	165/65R14	79T	Continental	Contieco	V	4821	0 mm
Spare	165/60R14	75H	Rapid	Radial	V	4122	0 mm
