CONDITION REPORT

Report No:
2017316371
DATE
23/10/2026

Vehicle Type	PASSENGER VEHICLE	Registered Owner	
Manufacturer	HYUNDAI	Registration Number	FP02ZCGP
Model	I10 1.1 MOTION 5-DR [2011-2018]	Register Number	
VIN	MALAN51BLHM691769	Date Of First Licensing	
Engine Number		Last COR	
Doors	5	License Expiry Date	30/06/2026
Color	WHITE	Power / Displacement	
Year Model	2016	Paint Finish	C - COMMON
Km Reading	128,857 KM	Fuel	PETROL
Cab / Body Type	HATCHBACK	Transmission	MANUAL

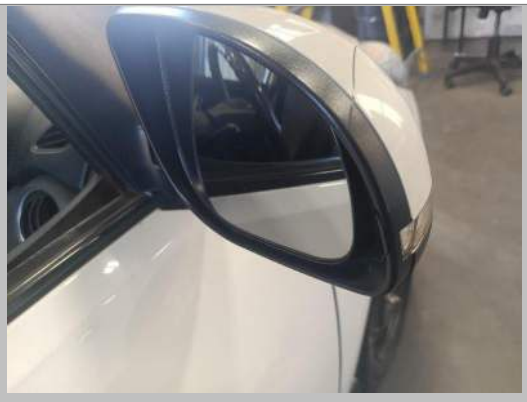
Damage	Repair Way
Battery clamps Defective	Repair
Windscreen Wiper Worn	Replace
Fog Light Front Right Defective	Repair
Seat Front Right Torn / Cut	Repair
Side Mirror Left Paintwork • Scratched	Repair
Side Mirror Right Cracked	Repair
Front Bumper Residual Traces of Repair	Repair
Bonnet Residual Traces of Repair	Repair
A • Pillar Right Dented	Repair
Front Fender Right Paintwork • Scratched	Repair
Rear Fender Right Paintwork • Scratched	Repair
Front Fender Left / Inner Tray Damaged	Replace
Front Fender Right / Inner Tray Damaged	Repair
Door Front Right Paintwork • Chipmarks	Repair
Door Rear Right Paintwork • Scratched	Repair
Boot Lid / Hatch door Paintwork • Scratched	Repair
Rear bumper Cracked	Repair
Sill Panel Left Damaged	Repair
Sill Panel Right Damaged	Repair
Windscreen Cracked	Replace
Tie Rod End right Defective	Replace
Stabilizer Mounting Front Left Defective	Replace
Stabilizer Mounting Front Right Defective	Repair
