CONDITION REPORT

Report No:
2017318755
DATE
28/10/2026

MFC Auction House
M57 Pretoria Rd, Glenmarais, KEMPTON PARK
Gauteng

Vehicle Type	PASSENGER VEHICLE	Registered Owner	
Manufacturer	HYUNDAI	Registration Number	ND62KHGP
Model	GRAND I10 1.0 MOTION 5-DR [2020-2024]	Register Number	
VIN	MALB251ALNM230814	Date Of First Licensing	
Engine Number		Last COR	
Doors	5	License Expiry Date	
Color	GREY	Power / Displacement	
Year Model	2021	Paint Finish	C - COMMON
Km Reading	208,709 KM	Fuel	PETROL
Cab / Body Type	HATCHBACK	Transmission	MANUAL

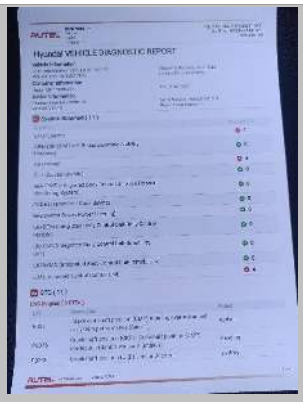
DIAGNOSTICS

During the diagnostic the following error messages were detected: (See also attached Diagnostic Report. For more information regarding the Fault Codes (DTC) and the recommended rectifications please contact the workshops of the vehicle manufacture).

No	System	Code	Description	Status
1	ENG(ENGINE)	P0011	INTAKE CAMSHAFT POSITION CMP ATIMING OVER ADVANCE OR SYSTEM PERFORMANCE (BANK 1)	ACTIVE

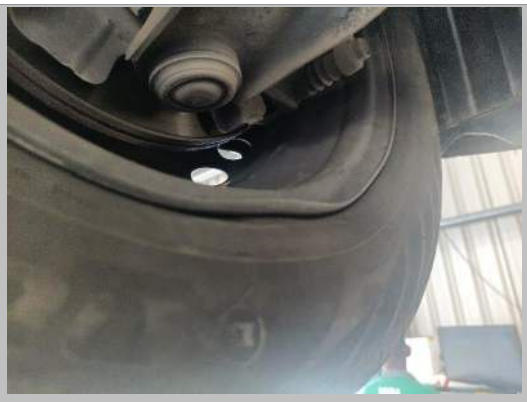
Sill Panel Left Residual Traces of Repair	Repair
Sill Panel Right Residual Traces of Repair	Repair
Roof Dented	Repair
Windscreen Cracked	Replace
Tyre Front Left Smooth	Replace
Rim Front Left Dented	Replace
Rim Rear Right Dented	Repair
Chassis Dented	Repair
Belly plates Cracked	Replace
Radiator Cradle Damaged	Repair
BODY EXTERIOR	signs of impact damage to front & back of vehicle
Airbag light illuminated	Repair
Rear tyres differs in size	Replace
