CONDITION REPORT

Report No:
2017317246
DATE
26/10/2026

Vehicle Type	PASSENGER VEHICLE	Registered Owner	MFC
Manufacturer	HYUNDAI	Registration Number	KK11HJGP
Model	GRAND I10 1.0 MOTION 5-DR [2020-2024]	Register Number	
VIN	MALB251ALNM252016	Date Of First Licensing	
Engine Number		Last COR	
Doors	5	License Expiry Date	28/02/2027
Color	WHITE	Power / Displacement	
Year Model	2023	Paint Finish	TWO COAT UNI
Km Reading	138,820 KM	Fuel	PETROL
Cab / Body Type	HATCHBACK	Transmission	MANUAL

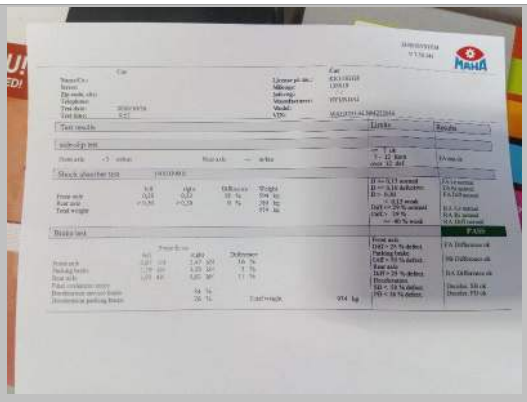
Brake test.

Left	Right		
	Braking Force [KN]	Braking Force [KN]	Axle Weight [KG]	Deceleration [m/s²]
Front	2.07	2.47	-	
Rear	1.29	1.63	-	
Emergency / Parking	1.29	1.23	-

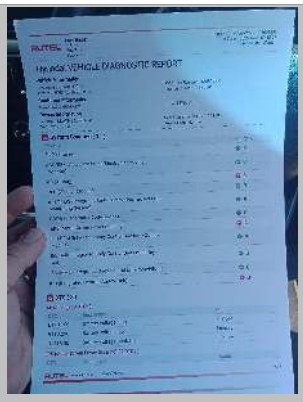
Diagnostic.

No	System	Code	Description	Status
1	AB	B1101:00	BATTERY VOLTAGE HIGH

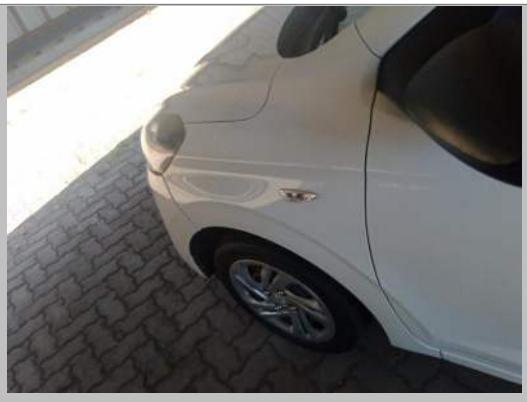
Damage	Repair Way
Engine Oil Sweat	Replace
Switch Electrical Window Winder front right Damaged	Repair
Headlight Left Scratched	Repair
Headlight Right Scratched	Repair
Seat Front Right Worn	Repair
Parcel Tray Damaged	Replace
Boot Carpet Missing	Repair
Front Bumper Damaged	Repair
Bonnet Damaged	Repair
Front Fender Left Residual Traces of Repair	Repair
Front Fender Right Damaged	Repair
Rear Fender Left Damaged	Repair
Rear Fender Right Damaged	Repair
Door Front Left Damaged	Repair
Door Front Right Damaged	Repair
Door Rear Left Damaged	Repair
Door Rear Right Damaged	Repair
Boot Lid / Hatch door Damaged	Repair
Rear bumper Damaged	Repair
Roof Damaged	Repair
Windscreen Damaged	Repair
Brake disc 1. Axle left Excessive Wear & Tear	Replace
Brake Pad 1. Axle left Excessive Wear & Tear	Repair
Tyre Front Right Worn	Repair
Spare Tyre Defective	Replace
Radiator Cradle Damaged	Repair
Brakes Noisy	Replace
Clutch Operation Incorrect	Repair
