CONDITION REPORT

Report No:
2017316250
DATE
23/10/2026

Vehicle Type	PASSENGER VEHICLE	Registered Owner	
Manufacturer	HYUNDAI	Registration Number	KY26NHGP
Model	GRAND I10 1.0 MOTION 5-DR [2020-2024]	Register Number	
VIN	MALB251ALPM367854	Date Of First Licensing	
Engine Number		Last COR	
Doors	5	License Expiry Date	28/02/2026
Color	RED	Power / Displacement	
Year Model	2022	Paint Finish	TWO COAT UNI
Km Reading	81,680 KM	Fuel	PETROL
Cab / Body Type	HATCHBACK	Transmission	MANUAL

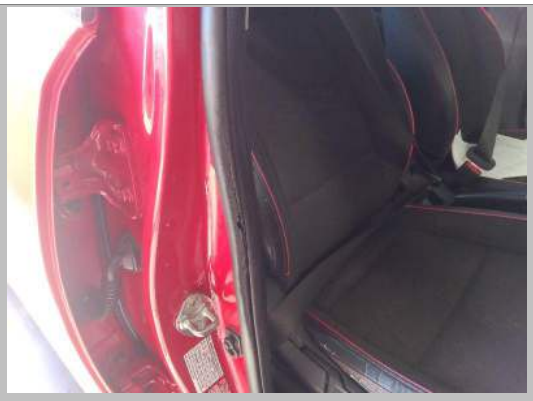
Damage	Repair Way
Engine Oil Sweat	Repair
Headlight Left Scratched	Repair
Seat Front Right Damaged	Repair
Seat Rear Dirty	Repair
Hood Lining Dirty	Repair
Door Sealing Rubber Front Right Damaged	Replace
Parcel Tray Damaged	Repair
Boot Carpet Damaged	Replace
Side Mirror Left Damaged	Replace
Front Bumper Paintwork • Scratched	Repair
Bonnet Paintwork • Scratched	Repair
Front Fender Left Paintwork • Scratched	Repair
Front Fender Right Dented	Repair
Rear Fender Left Paintwork • Scratched	Repair
Door Front Left Paintwork • Scratched	Repair
Door Front Right Damaged	Repair
Door Rear Left Damaged	Repair
Door Rear Right Paintwork • Scratched	Repair
Rear bumper Damaged	Repair
Sill Panel Left Paintwork • Scratched	Repair
Sill Panel Right Damaged	Repair
Roof Dented	Repair
Control Arm(s) Front Axle Left Damaged	Replace
Tyre Front Left Worn	Replace
Tyre Front Right Worn	Replace
Rim Front Left Dented	Repair
Rim Rear Left Dented	Repair
