CONDITION REPORT

Report No:
2017309572
DATE
08/10/2026

Vehicle Type	PASSENGER VEHICLE	Registered Owner	MFC
Manufacturer	HYUNDAI	Registration Number	LG02LZGP
Model	GRAND I10 1.0 MOTION 5-DR [2020-2024]	Register Number	
VIN	MALB251ALPM416320	Date Of First Licensing	
Engine Number		Last COR	
Doors	5	License Expiry Date	
Color	WHITE	Power / Displacement	
Year Model	2023	Paint Finish	TWO COAT UNI
Km Reading	44,850 KM	Fuel	PETROL
Cab / Body Type	HATCHBACK	Transmission	MANUAL

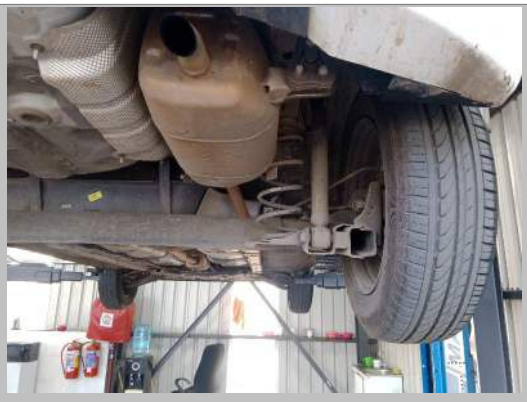
LR TYRE TREAD

Size	Load/Speed Index	Manufacture	Model	Type*	Production Date	Tread Depth (mm)
Front Left	165/70R14	81T	Goodyear	Assurance	V	5222	2 mm
Front Right	165/70R14	81T	Goodyear	Assurance	V	5122	2 mm
Rear Left	165/70R14	81T	Goodyear	Assurance	V	5222	2 mm
Rear Right	165/70R14	81T	Goodyear	Assurance	V	5222	3 mm
