CONDITION REPORT

Report No:
2017316040
DATE
22/10/2026

Vehicle Type	PASSENGER VEHICLE	Registered Owner	MFC AUCTION HOUSE
Manufacturer	HYUNDAI	Registration Number	LT71SKGP
Model	GRAND I10	Register Number	
VIN	MALB251ALRM522570	Date Of First Licensing	
Engine Number		Last COR	
Doors	5	License Expiry Date	
Color	WHITE	Power / Displacement	
Year Model		Paint Finish	TWO COAT UNI
Km Reading	115,919 KM	Fuel	PETROL
Cab / Body Type	HATCHBACK	Transmission	MANUAL

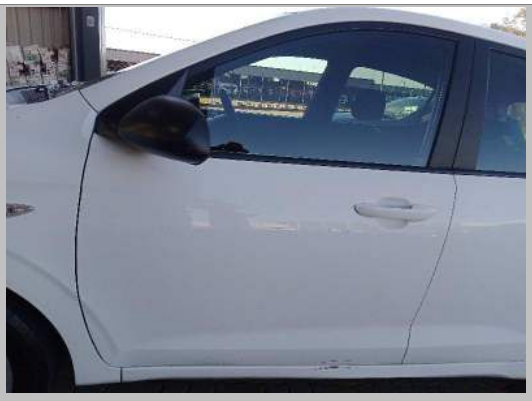
Damage	Repair Way
Engine Oil Sweat	Repair
Engine Wiring Defective	Repair
Switch Electrical Window Winder rear right Damaged	Replace
Windscreen Wiper Damaged	Replace
Tail Light Left Defective	Repair
Tail Light Right Defective	Repair
Seat Front Left Dirty	Repair
Door Sealing Rubber Front Left Damaged	Replace
Parcel Tray Damaged	Repair
Front Bumper Paintwork • Scratched	Repair
Bonnet Dented	Repair
Rear Fender Left Paintwork • Scratched	Repair
Door Front Left Paintwork • Scratched	Repair
Door Front Right Dented	Repair
Door Rear Left Dented	Repair
Door Rear Right Dented	Repair
Rear bumper Paintwork • Scratched	Repair
Inner Boot Floor Pan and Spare Wheel Well Dented	Repair
Sill Panel Left Damaged	Repair
Roof Dented	Repair
Parking Brake Performance Left / Right Difference out of legal range	Repair
Tyre Front Left Damaged	Replace
Tyre Rear Left Worn	Replace
Tyre Rear Right Damaged	Replace
Rim Front Right Dented	Repair
Rim Spare Wheel Dented	Repair
