CONDITION REPORT

Report No:
2017309870
DATE
09/10/2026

Vehicle Type	PASSENGER VEHICLE	Registered Owner	MFC
Manufacturer	HYUNDAI	Registration Number	MD05VMGP
Model	GRAND I10	Register Number	
VIN	MALB251ALSM539787	Date Of First Licensing	
Engine Number		Last COR	
Doors	5	License Expiry Date	31/12/2026
Color	WHITE	Power / Displacement	
Year Model		Paint Finish	TWO COAT UNI
Km Reading	87,913 KM	Fuel	PETROL
Cab / Body Type	HATCHBACK	Transmission	MANUAL

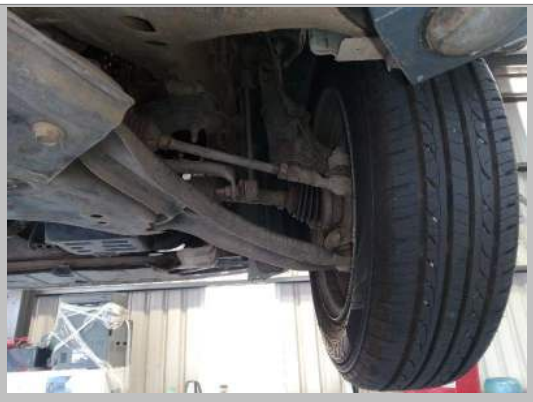
LF TYRE TREAD

Size	Load/Speed Index	Manufacture	Model	Type*	Production Date	Tread Depth (mm)
Front Left	165/70 R14	81T	Anchee	AC808	V	2026	5 mm
Front Right	165/70 R14	81T	Anchee	AC808	V	2026	4 mm
Rear Left	165/70 R14	81T	Goodyear	Assurance	V	0924	1 mm
Rear Right	165/70 R14	81T	Goodyear	Assurance	V	0924	3 mm
Spare	165/70 R14	81T	Goodyear	Assurance	V	0924	5 mm

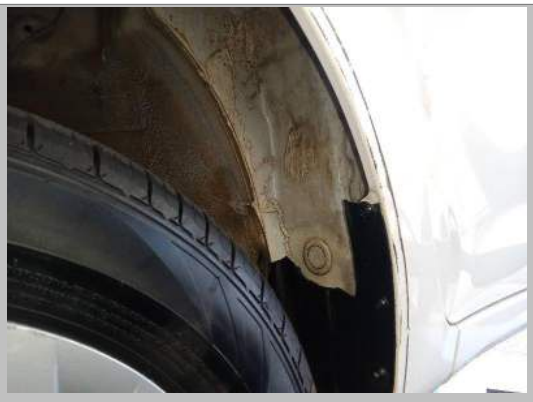
Damage	Repair Way
Engine Oil Leak	Repair
Seat Rear Damaged	Repair
Door Sealing Rubber Front Right Damaged	Replace
Parcel Tray Damaged	Repair
Dash Padding Damaged	Repair
Front Bumper Residual Traces of Repair	Replace
Grill Damaged	Replace
Bonnet Paintwork • Chipmarks	Repair
Front Fender Left Residual Traces of Repair	Repair
Front Fender Right Defective	Repair
Rear Fender Left Dented	Repair
Front Fender Left / Inner Tray Damaged	Replace
Rear Fender Right / Inner Tray Damaged	Repair
Rear bumper Paintwork • Scratched	Repair
Rear Axle Damaged	Repair
Control Arm(s) Front Axle Left Damaged	Replace
Rim Front Left Dented	Repair
Chassis Dented	Repair
Belly plates Damaged	Replace
Fuel Tank Dented	Repair
Radiator Cradle Damaged	Repair
Loose sound wiring inside boot of vehicle	Repair
