CONDITION REPORT

Report No:
2017316254
DATE
23/10/2026

Vehicle Type	PASSENGER VEHICLE	Registered Owner	MFC
Manufacturer	HYUNDAI	Registration Number	MF12DKGP
Model	GRAND I10	Register Number	
VIN	MALB251ALSM619138	Date Of First Licensing	
Engine Number		Last COR	
Doors	5	License Expiry Date	31/05/2027
Color	GREEN	Power / Displacement	
Year Model		Paint Finish	C - COMMON
Km Reading	99,837 KM	Fuel	PETROL
Cab / Body Type	HATCHBACK	Transmission	MANUAL

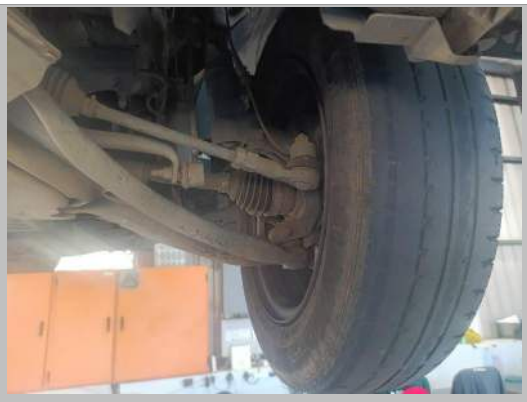
LF TYRE TREAD

Size	Load/Speed Index	Manufacture	Model	Type*	Production Date	Tread Depth (mm)
Front Left	165/70R14	81T	Goodyear	Assurance	V	4724	1 mm
Front Right	165/70R14	81T	Goodyear	assurance	V	4524	1 mm
Rear Left	165/70R14	81T	Goodyear	Assurance	V	4724	2 mm
Rear Right	165/70R14	81T	Goodyear	Assurance	V	4724	3 mm
Spare	165/70R14	81T	Goodyear	assurance	V	0000	2 mm

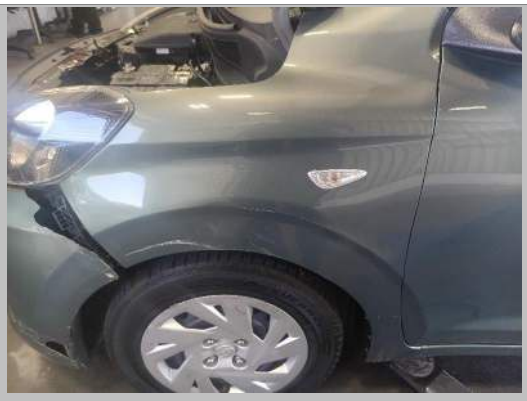
Front Bumper

General Comments: ACCORDING TO THE AGE AND MILEAGE OF THE VEHICLE, NORMAL WEAR AND TEAR MARKS ARE VISIBLE ON THE INTERIOR, EXTERIOR, ELECTRICAL AND MECHANICAL PARTS.SIGNS OF IMPACT DAMAGE FRONT OF VEHICLE / SIGNS OF SURFACE RUST FRONT LEFT MAIN BEAM.
