CONDITION REPORT

Report No:
2017315272
DATE
21/10/2026

Vehicle Type	PASSENGER VEHICLE	Registered Owner	MFC AUCTION HOUSE
Manufacturer	HYUNDAI	Registration Number	ML56PSGP
Model	GRAND I10	Register Number	
VIN	MALB251ALSM667453	Date Of First Licensing	
Engine Number		Last COR	
Doors	5	License Expiry Date	30/06/2027
Color	WHITE	Power / Displacement	
Year Model		Paint Finish	C - COMMON
Km Reading	56,236 KM	Fuel	PETROL
Cab / Body Type	HATCHBACK	Transmission	MANUAL

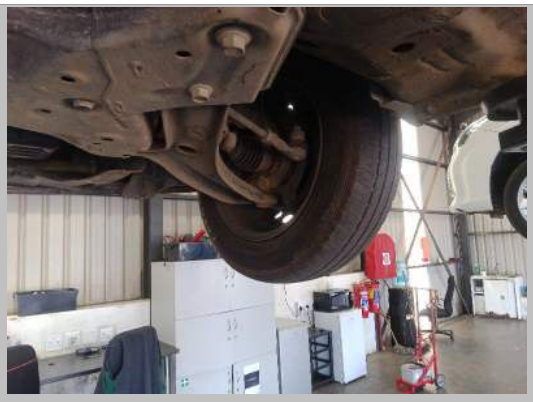
RR TYRE TREAD

Size	Load/Speed Index	Manufacture	Model	Type*	Production Date	Tread Depth (mm)
Front Left	165/70R14	81T	Goodyear	Assurance	V	1625	3 mm
Front Right	165/70R14	81T	Goodyear	Assurance	V	1425	3 mm
Rear Left	165/70R14	81T	Goodyear	Assurance	V	1625	3 mm
Rear Right	165/70R14	81T	Goodyear	Assurance	V	1625	3 mm
Spare	185/70R14	81T	Goodyear	Assurance	V	1625	4 mm
