# CONDITION REPORT

**Report No:**
**2017309113**
**DATE**
**08/10/2026**

*MFC Auction House*
*M57 Pretoria Rd, Glenmarais, KEMPTON PARK*
*Gauteng*

| Manufacturer | HYUNDAI | Registration Number | MR35PPGP |

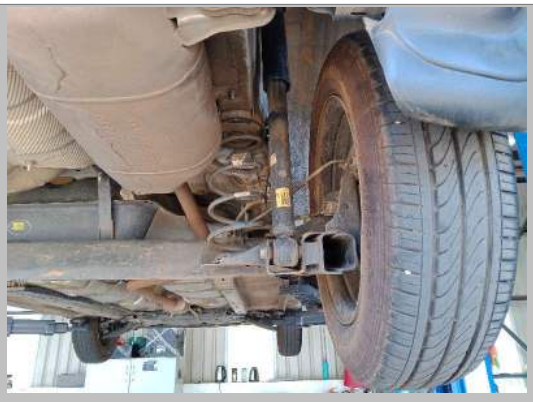
Brake and shock absorber repor

| Damage | Repair Way |
|---|---|
| Deceleration service brake defective | Repair |

| | Left | Right | | |
|---|---|---|---|---|
| | Braking Force [KN] | Braking Force [KN] | Axle Weight [KG] | Deceleration [m/s²] |
| **Front** | 2.48 | 2.52 | - | |
| **Rear** | 1.3 | 1.12 | - | |
| **Emergency / Parking** | 1.39 | 1.23 | - | |

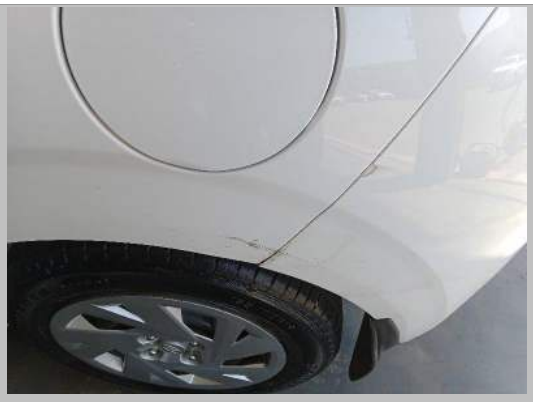
| Damage | Repair Way |
|---|---|
| Rear Fender Left Paintwork • Scratched | Repair |
