CONDITION REPORT

Report No:
2017315982
DATE
22/10/2026

Vehicle Type	PASSENGER VEHICLE	Registered Owner	MFC
Manufacturer	HYUNDAI	Registration Number	MX80BFGP
Model	GRAND I10 1.25 FLUID 5-DR [2014-2017]	Register Number	
VIN	MALB251ALTM718883	Date Of First Licensing	
Engine Number		Last COR	
Doors	5	License Expiry Date	31/03/2027
Color	SILVER	Power / Displacement	
Year Model	2016	Paint Finish	TWO COAT METALLIC
Km Reading	27,676 KM	Fuel	PETROL
Cab / Body Type	HATCHBACK	Transmission	MANUAL

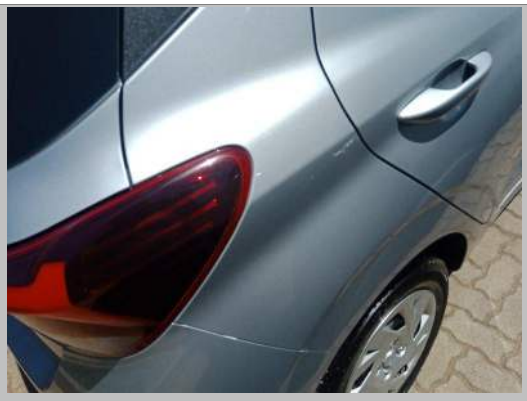
Damage	Repair Way
Front Bumper Damaged	Repair
Front Fender Right Damaged	Repair
Rear Fender Right Damaged	Repair
Rear bumper Damaged	Repair
Roof Damaged	Repair
Windscreen Damaged	Replace
