CONDITION REPORT

Report No:
2017316330
DATE
26/10/2026

Vehicle Type	PASSENGER VEHICLE	Registered Owner	MFC
Manufacturer	HYUNDAI	Registration Number	LK31YHGP
Model	GRAND I10 1.2 MOTION 5-DR AT [2023-2024]	Register Number	
VIN	MALB251CMRM467143	Date Of First Licensing	
Engine Number		Last COR	
Doors	5	License Expiry Date	30/11/2026
Color	GREY	Power / Displacement	
Year Model	2023	Paint Finish	C - COMMON
Km Reading	36,117 KM	Fuel	PETROL
Cab / Body Type	HATCHBACK	Transmission	AUTOMATIC

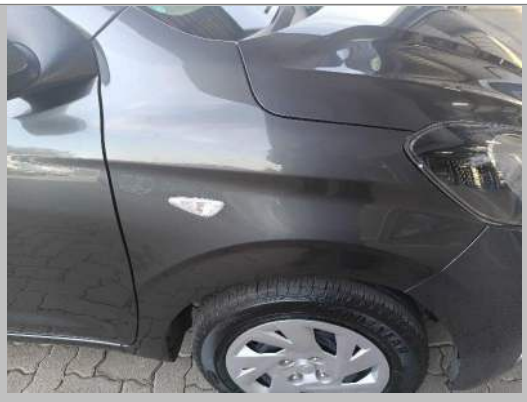
Damage	Repair Way
Seat Front Right Worn	Repair
Front Bumper Damaged	Repair
Front Fender Right Residual Traces of Repair	Repair
Rear Fender Right Residual Traces of Repair	Repair
Front Fender Left / Inner Tray Damaged	Replace
Front Fender Right / Inner Tray Damaged	Replace
Door Front Left Dented	Repair
Door Front Right Paintwork • Scratched	Repair
Door Rear Right Residual Traces of Repair	Repair
Boot Lid / Hatch door Dented	Repair
Windscreen Cracked	Replace

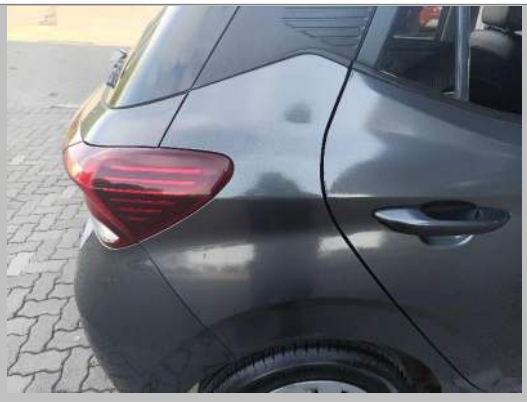
Rear Fender Right

General Comments: ACCORDING TO THE AGE AND MILEAGE OF THE VEHICLE, NORMAL WEAR AND TEAR MARKS ARE VISIBLE ON THE INTERIOR, EXTERIOR, ELECTRICAL AND MECHANICAL PARTS.Body • Exterior: Residual traces of poor repair on body.
