CONDITION REPORT

Report No:
2017307933
DATE
06/10/2026

Vehicle Type	PASSENGER VEHICLE	Registered Owner	MFC
Manufacturer	HYUNDAI	Registration Number	LLC495MP
Model	EXTER	Register Number	
VIN	MALB281CLSM146358	Date Of First Licensing	
Engine Number		Last COR	
Doors	5	License Expiry Date	
Color	WHITE	Power / Displacement	
Year Model		Paint Finish	C - COMMON
Km Reading	24,662 KM	Fuel	PETROL
Cab / Body Type	HATCHBACK	Transmission	MANUAL

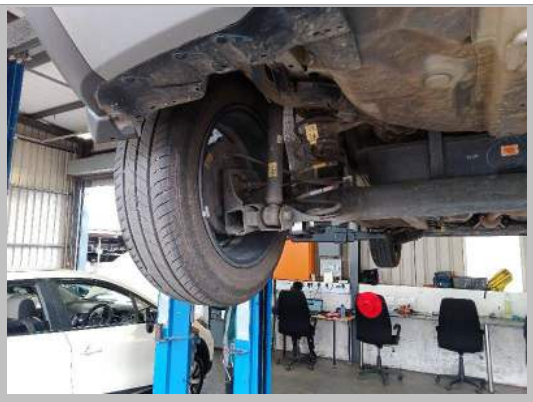
RF TYRE TREAD

Size	Load/Speed Index	Manufacture	Model	Type*	Production Date	Tread Depth (mm)
Front Left	175/65R15	84H	Ceat	Securadrive	V	4424	3 mm
Front Right	175/65R15	84H	Ceat	Securadrive	V	4424	3 mm
Rear Left	175/65R15	84H	Ceat	Securadrive	V	4424	3 mm
Rear Right	175/65R15	84H	Ceat	Securadrive	V	4424	3 mm
Spare	165/70R14	81T	Apollo	Amazer	V	0000	4 mm
