CONDITION REPORT

Report No:
2017305669
DATE
01/10/2026

Vehicle Type	PASSENGER VEHICLE	Registered Owner	MFC
Manufacturer	HYUNDAI	Registration Number	KG30HKGP
Model	I20 1.0 TGDI FLUID 5-DR DCT [2021-2024]	Register Number	
VIN	MALBG511VNM091627	Date Of First Licensing	
Engine Number		Last COR	
Doors	5	License Expiry Date	30/11/2026
Color	RED	Power / Displacement	
Year Model	2021	Paint Finish	M - METALLIC
Km Reading	131,774 KM	Fuel	PETROL
Cab / Body Type	HATCHBACK	Transmission	AUTOMATIC

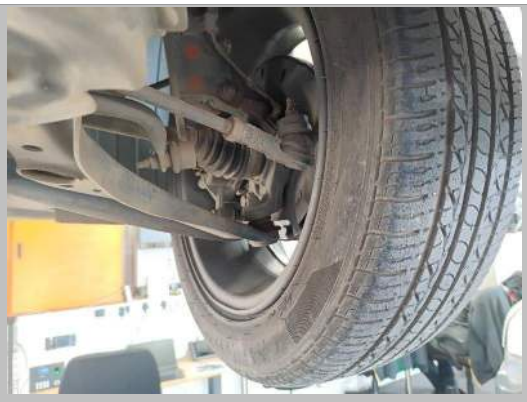
LF TYRE TREAD

Size	Load/Speed Index	Manufacture	Model	Type*	Production Date	Tread Depth (mm)
Front Left	195/55R16	91V	Anchee	AC808	V	0124	2 mm
Front Right	195/55R16	91V	Anchee	AC808	V	0124	1 mm
Rear Left	195/55R16	87V	Ceat	Securadrive	V	3121	2 mm
Rear Right	195/55R16	91V	Cachland	CH	V	2822	0 mm
Spare	195/55R16	87H	Bridgestone	Turanza	V	0000	0 mm

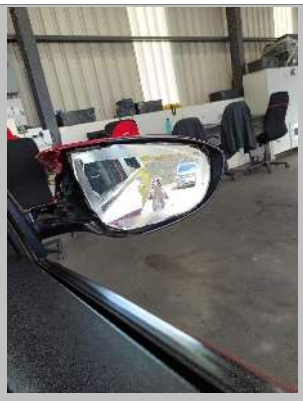
Damage	Repair Way
Seat Front Left Torn / Cut	Repair
Seat Front Right Torn / Cut	Repair
Steering Wheel Trim Torn / Cut	Repair
Side Mirror Left Paintwork • Scratched	Repair
Side Mirror Right Damaged	Repair
Front Bumper Paintwork • Scratched	Repair
Door Front Left Dented	Repair
Door Front Right Dented	Repair
Door Rear Right Paintwork • Scratched	Repair
Fuel Flap Damaged	Repair
Windscreen Cracked	Replace
Tyre Rear Right Smooth	Replace
Spare Tyre Smooth	Replace
Rim Front Right Deformed	Repair
Belly plates Damaged	Repair
Steering Insufficient	Repair
Engine Noise Excessive	Repair
Warning lights illuminated	Repair

No	System	Code	Description	Status
1	MOTOR DRIVEN POWER STEERING	C2413:01	MOTOR CURRENT FAIL(OVERCURRENT)
