CONDITION REPORT

Report No:
2017315252
DATE
21/10/2026

Vehicle Type	PASSENGER VEHICLE	Registered Owner	
Manufacturer	HYUNDAI	Registration Number	LB67DPGP
Model	I20 1.2 MOTION 5-DR [2021-2024]	Register Number	
VIN	MALBG512LPM196131	Date Of First Licensing	
Engine Number		Last COR	
Doors	5	License Expiry Date	31/12/2026
Color	GREY	Power / Displacement	
Year Model	2023	Paint Finish	C - COMMON
Km Reading	111,155 KM	Fuel	PETROL
Cab / Body Type	HATCHBACK	Transmission	MANUAL

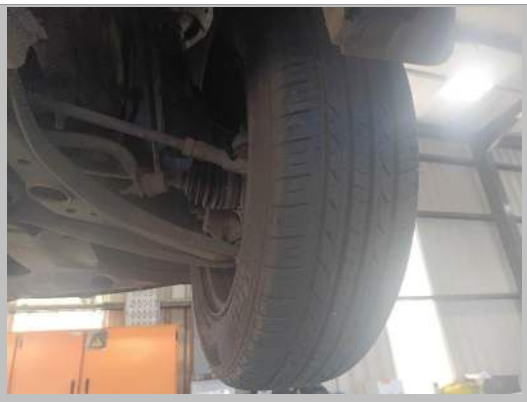
LF TYRE TREAD

Size	Load/Speed Index	Manufacture	Model	Type*	Production Date	Tread Depth (mm)
Front Left	185/65R15	88H	Annaite	An600	V	0125	4 mm
Front Right	185/65R15	88H	Annaite	An600	V	0125	4 mm
Rear Left	185/65R15	88H	Bridgestone	Ecopia	V	4922	4 mm
Rear Right	185/65R15	88H	Bridgestone	Ecopia	V	4922	4 mm

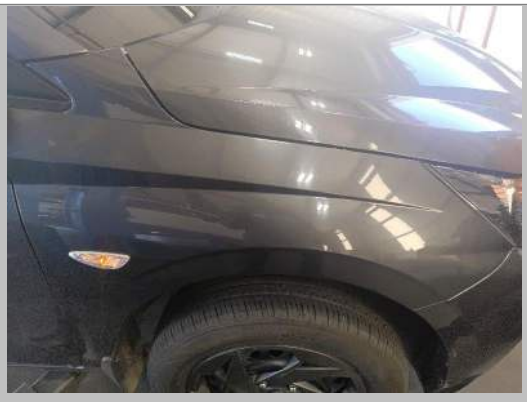
Damage	Repair Way
Seat Front Right Excessive Wear & Tear	Repair
Door Sealing Rubber Front Left Worn	Replace
Door Sealing Rubber Front Right Excessive Wear & Tear	Replace
Door Sealing Rubber Rear Left Excessive Wear & Tear	Replace
Door Lock Boot Lid Defective	Repair
Side Mirror Left Damaged	Replace
Front Bumper Damaged	Repair
Bonnet Paintwork • Scratched	Repair
Bonnet slam plate (Shock tower/ Inner tray) Damaged	Repair
Front Fender Left Dented	Repair
Front Fender Right Residual Traces of Repair	Repair
Rear Fender Left Paintwork • Scratched	Repair
Rear Fender Right Residual Traces of Repair	Repair
Door Front Left Dented	Repair
Door Front Right Residual Traces of Repair	Repair
Door Rear Left Paintwork • Scratched	Repair
Door Rear Right Residual Traces of Repair	Repair
Boot Lid / Hatch door Dented	Repair
Rear bumper Residual Traces of Repair	Repair
Windscreen Chipped	Repair
Belly plates Damaged	Replace
Warning light illuminated	Repair
