CONDITION REPORT

Report No:
2017316013
DATE
22/10/2026

Vehicle Type	PASSENGER VEHICLE	Registered Owner	MFC AUCTION HOUSE
Manufacturer	HYUNDAI	Registration Number	LD96TRGP
Model	I20 1.2 MOTION 5-DR [2021-2024]	Register Number	
VIN	MALBG512LPM197066	Date Of First Licensing	
Engine Number		Last COR	
Doors	5	License Expiry Date	
Color	GREY	Power / Displacement	
Year Model	2023	Paint Finish	M - METALLIC
Km Reading	81,405 KM	Fuel	PETROL
Cab / Body Type	HATCHBACK	Transmission	MANUAL

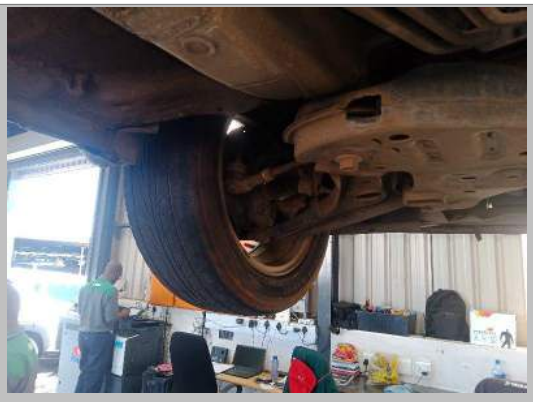
LF TYRE TREAD

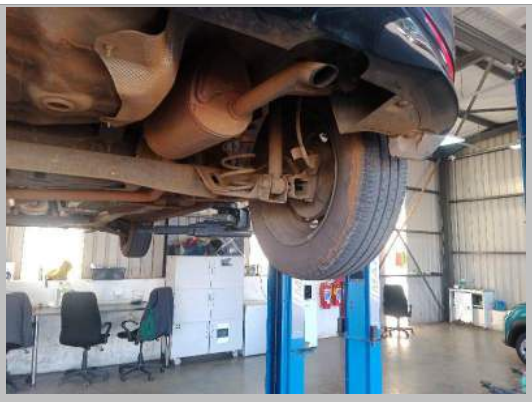
RF TYRE TREAD
