CONDITION REPORT

Report No:
2017312641
DATE
15/10/2026

Vehicle Type	PASSENGER VEHICLE	Registered Owner	
Manufacturer	HYUNDAI	Registration Number	MS57BGGP
Model	I20	Register Number	
VIN	MALBG512LTM385696	Date Of First Licensing	
Engine Number		Last COR	
Doors	5	License Expiry Date	31/12/2026
Color	WHITE	Power / Displacement	
Year Model		Paint Finish	TWO COAT METALLIC
Km Reading	20,727 KM	Fuel	PETROL
Cab / Body Type	HATCHBACK	Transmission	MANUAL

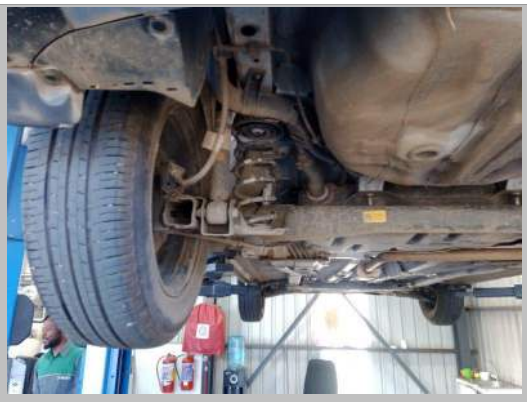
RF TYRE TREAD

Size	Load/Speed Index	Manufacture	Model	Type*	Production Date	Tread Depth (mm)
Front Left	185/65R15	88H	Bridgestone	Radial	V	2825	3 mm
Front Right	185/65R15	88H	Bridgestone	Radial	V	2925	3 mm
Rear Left	185/65R15	88H	Bridgestone	Radial	V	2625	3 mm
Rear Right	185/65R15	84H	Bridgestone	Radial	V	2825	3 mm
Spare	185/65R15	88H	Bridgestone	Radial	V	0000	4 mm
