CONDITION REPORT

Report No:
2017314859
DATE
21/10/2026

Vehicle Type	PASSENGER VEHICLE	Registered Owner	MFC AUCTION HOUSE
Manufacturer	HYUNDAI	Registration Number	HP32SYGP
Model	I20	Register Number	
VIN	MALBM51BLKM516025	Date Of First Licensing	
Engine Number		Last COR	
Doors	5	License Expiry Date	31/03/2026
Color	RED	Power / Displacement	
Year Model		Paint Finish	TWO COAT UNI
Km Reading	182,859 KM	Fuel	PETROL
Cab / Body Type	HATCHBACK	Transmission	MANUAL

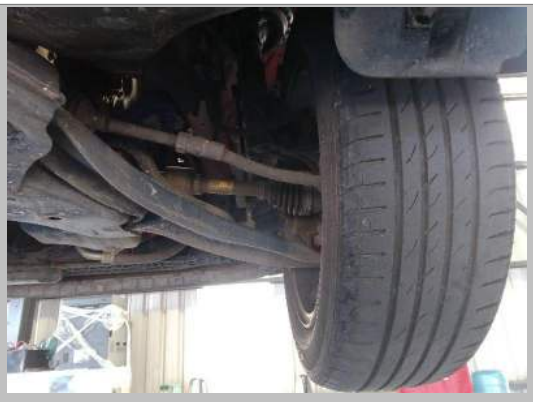
Front chassis

Sill Panel Left Residual Traces of Repair	Repair
Sill Panel Right Damaged	Repair
Roof Dented	Repair
Windscreen Chipped	Repair
Tyre Front Right Damaged	Replace
Tyre Rear Right Torn / Cut	Replace
Rim Front Right Scratched	Repair
Rim Rear Left Scratched	Replace
Bolt(s) / Nut(s) Front Wheel Left Missing	Replace
Bolt(s) / Nut(s) Front Wheel Right Missing	Replace
Bolt(s) / Nut(s) Rear Wheel Left Missing	Replace
Bolt(s) / Nut(s) Rear Wheel Right Missing	Replace
Chassis Damaged	Repair
Belly plates Damaged	Replace
Radiator Cradle Damaged	Replace
Boot does not open	Repair

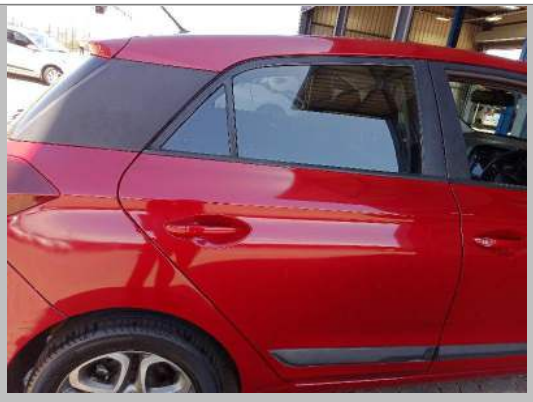
Damage	Repair Way
Fan Belt Torn / Cut	Replace
Headlight Left Defective	Repair
Headlight Right Defective	Repair
Seat Front Right Damaged	Repair
Seat Rear Dirty	Repair
Side Mirror Right Paintwork • Chipmarks	Repair
Front Bumper Paintwork • Scratched	Repair
Bonnet Residual Traces of Repair	Repair
B • Pillar Right Residual Traces of Repair	Repair
C • Pillar Right Residual Traces of Repair	Repair
Front Fender Right Residual Traces of Repair	Repair
Rear Fender Left Residual Traces of Repair	Repair
Rear Fender Right Residual Traces of Repair	Repair
Front Fender Right / Inner Tray Damaged	Replace
Rear Fender Left / Inner Tray Damaged	Repair
Door Front Left Residual Traces of Repair	Repair
Door Front Right Paintwork • Scratched	Repair
Door Rear Left Residual Traces of Repair	Repair
Door Rear Right Residual Traces of Repair	Repair
Boot Lid / Hatch door Residual Traces of Repair	Repair
Rear bumper Paintwork • Scratched	Repair
