CONDITION REPORT

Report No:
2017315455
DATE
21/10/2026

Vehicle Type	PASSENGER VEHICLE	Registered Owner	
Manufacturer	HYUNDAI	Registration Number	JK87RMGP
Model	I20 1.2 MOTION 5-DR [2018-2021]	Register Number	
VIN	MALBM51BLLM726496	Date Of First Licensing	
Engine Number		Last COR	
Doors	5	License Expiry Date	28/02/2025
Color	SILVER	Power / Displacement	
Year Model	2020	Paint Finish	TWO COAT UNI
Km Reading	205,930 KM	Fuel	PETROL
Cab / Body Type	HATCHBACK	Transmission	MANUAL

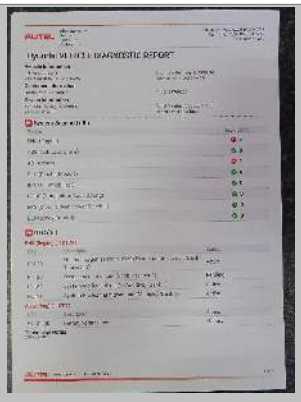
Diagnostic report page 1

No	System	Code	Description	Status
1	ENG(ENGINE)	P0030	HEATED OXYGEN SENSOR(HO2S) HEATER CONTROL CIRCUIT(

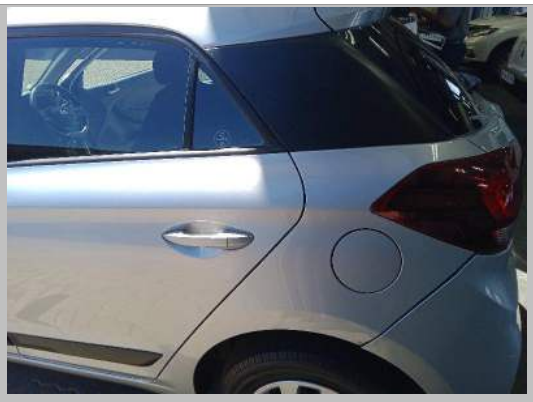
Damage	Repair Way
Engine Oil Leak	Repair
Fan Belt Torn / Cut	Replace
Switch Electrical Window Winder front left Malfunction	Replace
Side Mirror Right Paintwork • Scratched	Repair
Front Bumper Paintwork • Scratched	Repair
Bonnet Residual Traces of Repair	Repair
Front Fender Right Damaged	Repair
Rear Fender Left Dented	Repair
Rear Fender Right Dented	Repair
Front Fender Right / Inner Tray Residual Traces of Repair	Repair
Door Front Left Dented	Repair
Door Rear Left Dented	Repair
Rear bumper Damaged	Repair
Sill Panel Left Dented	Repair
Roof Dented	Repair
Windscreen Chipped	Repair
Tyre Front Left Worn	Replace
Tyre Front Right Damaged	Replace
Tyre Rear Left Worn	Replace
Spare Tyre Worn	Replace
Main Beam Left Dented	Repair
Chassis Damaged	Repair
