# CONDITION REPORT

**Report No:**
**2017314527**
**DATE**
**20/10/2026**

| Manufacturer | HYUNDAI | Registration Number | JN28GXGP |
| Model | VENUE 1.0 88KW TGDI MOTION INFOTAINMENT AT [2021-2023] | Register Number | |

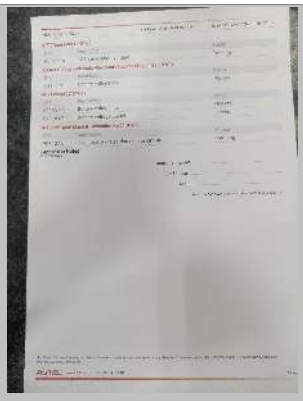
Diagnostics

| No | System | Code | Description | Status |
|---|---|---|---|---|
| 1 | ENGINE | P2565:00 | TURBOCHARGER BOOST CONTROL POSITION SENSOR A CIRCIT HIGH | ACTIVE |

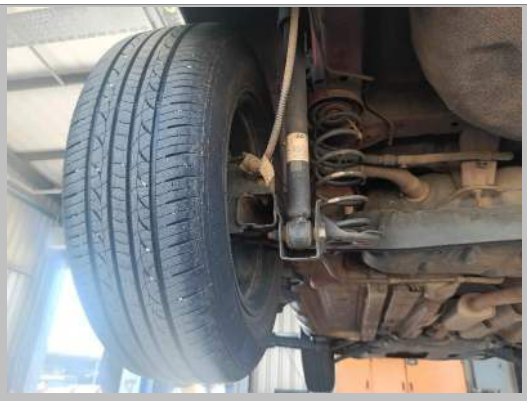
LF TYRE TREAD

| Damage | Repair Way |
|---|---|
| Tyre Front Left Worn | Replace |

| | Size | Load/Speed Index | Manufacture | Model | Type* | Production Date | Tread Depth (mm) |
|---|---|---|---|---|---|---|---|
| **Front Left** | 195/65R15 | 91V | Dunlop | Sport FM800 | V | 0725 | 0 mm |

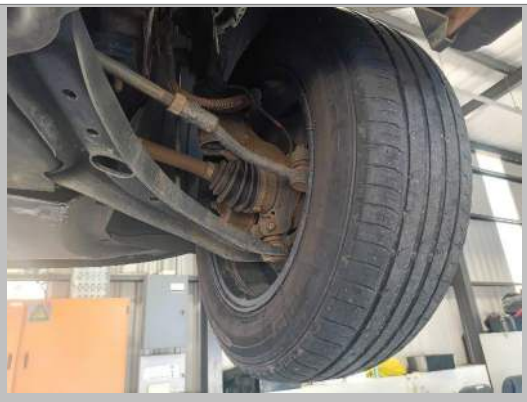
LR TYRE TREAD

| Damage | Repair Way |
|---|---|
| Rear left and right tyre sizes different | Replace |

| | Size | Load/Speed Index | Manufacture | Model | Type* | Production Date | Tread Depth (mm) |
|---|---|---|---|---|---|---|---|
| **Rear Left** | 195/65R15 | 91H | Anchee | AC808 | V | 0925 | 3 mm |

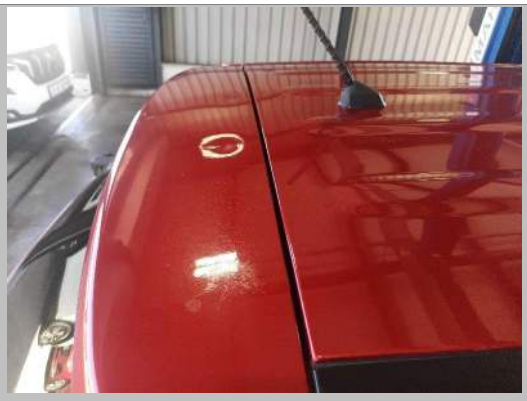
| Damage | Repair Way |
|---|---|
| Boot Lid / Hatch door Dented | Repair |

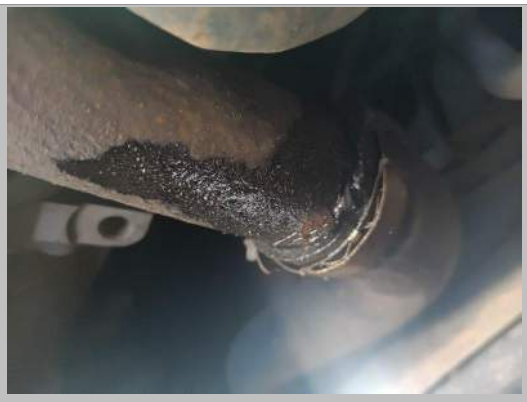
| Damage | Repair Way |
|---|---|
| Hoses Oil Leak | Repair |

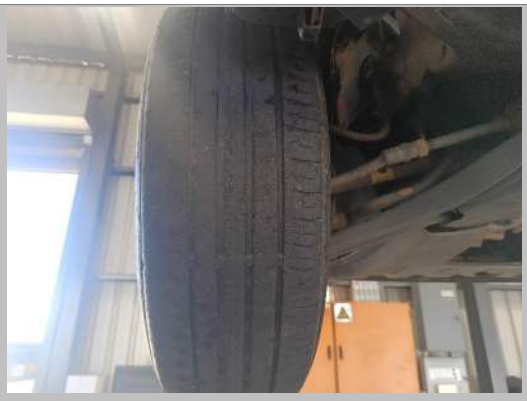
| Damage | Repair Way |
|---|---|
| Tyre Front Right Worn | Replace |

| | Size | Load/Speed Index | Manufacture | Model | Type* | Production Date | Tread Depth (mm) |
|---|---|---|---|---|---|---|---|
| **Front Right** | 195/65R15 | 91V | Dunlop | Sport FM800 | V | 0725 | 0 mm |
