CONDITION REPORT

Report No:
2017307436
DATE
05/10/2026

Vehicle Type	PASSENGER VEHICLE	Registered Owner	MFC
Manufacturer	HYUNDAI	Registration Number	JZ46LRGP
Model	VENUE 1.0 88KW TGDI MOTION INFOTAINMENT AT [2021-2023]	Register Number	
		Date Of First Licensing	
VIN	MALFB81AVMM169859	Last COR	
Engine Number		License Expiry Date	
Doors	5	Power / Displacement	
Color	RED	Paint Finish	TWO COAT UNI
Year Model	2021	Fuel	PETROL
Km Reading	119,041 KM	Transmission	AUTOMATIC
Cab / Body Type	HATCHBACK

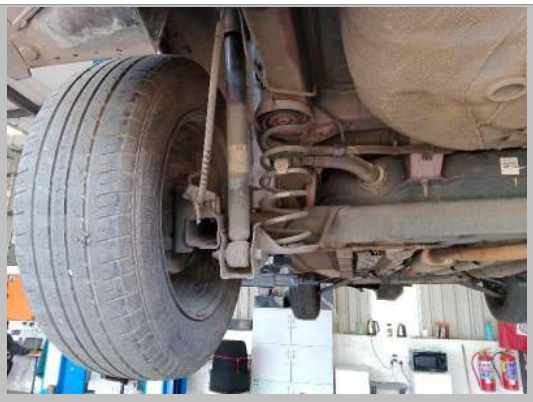
RF TYRE TREAD

Size	Load/Speed Index	Manufacture	Model	Type*	Production Date	Tread Depth (mm)
Front Left	195/65 R15	91H	Goodyear	Assurance	V	0721	1 mm
Front Right	195/65 R15	91H	Goodyear	Assurance	V	0721	0 mm
Rear Left	195/65 R15	91H	Goodyear	Assurance	V	0621	2 mm
Rear Right	195/65 R15	91H	Goodyear	Assurance	V	0721	1 mm
Spare	195/65 R15	91H	Goodyear	Assurance	V	0000	0 mm

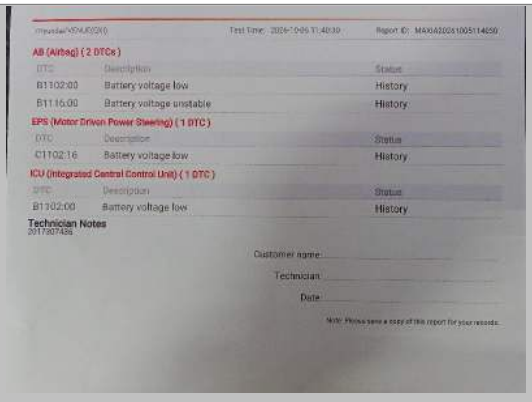
Diagnostic report page 1

No	System	Code	Description	Status
1	ABS/ESP(ANTI-LOCK BRAKE/ELECTRONIC STABILITY PROGR	C1623:08	CAN TIMEOUT-STEERING ANGLE SENSOR(SAS)

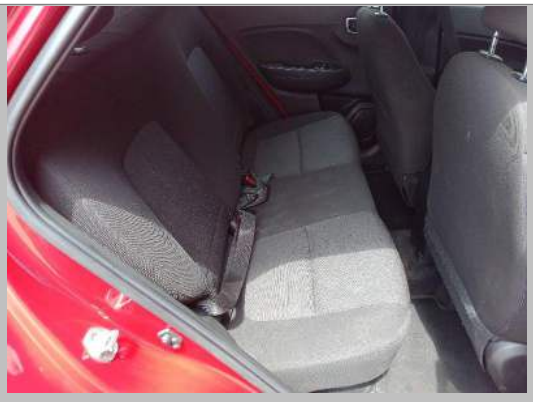
Damage	Repair Way
Hoses Oil Leak	Replace
Fan Belt Torn / Cut	Replace
Air conditioner pipes Damaged	Repair
Headlight Right Damaged	Replace
Seat Front Left Dirty	Repair
Seat Front Right Damaged	Repair
Seat Rear Damaged	Repair
Hood Lining Dirty	Repair
Door Sealing Rubber Front Left Damaged	Replace
Door Sealing Rubber Front Right Damaged	Replace
Door Sealing Rubber Rear Left Missing	Replace
Door Sealing Rubber Rear Right Damaged	Replace
Door Lock Front Right Damaged	Replace
Boot Carpet Damaged	Repair
Side Mirror Right Residual Traces of Repair	Replace
Front Bumper Damaged	Replace
Bonnet Dented	Repair
Front Fender Left Damaged	Repair
Front Fender Right Damaged	Repair
Rear Fender Left Damaged	Repair
Rear Fender Right Damaged	Repair
Front Fender Right / Inner Tray Damaged	Replace
Rear Fender Left / Inner Tray Damaged	Replace
Door Front Left Damaged	Repair
Door Front Right Dented	Repair
Door Rear Left Damaged	Repair
Boot Lid / Hatch door Paintwork • Scratched	Repair

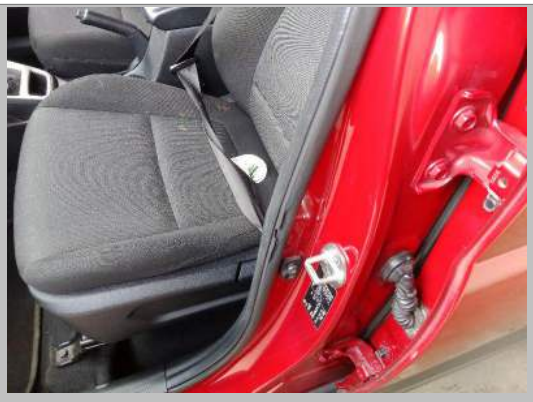
Rear bumper Damaged	Repair
Roof Dented	Repair
Windscreen Chipped	Repair
Tyre Front Left Damaged	Replace
Tyre Front Right Worn	Replace
Spare Tyre Damaged	Replace
Rim Front Left Dented	Repair
Rim Front Right Dented	Repair
Rim Spare Wheel Dented	Repair
Engine to silencer pipe Damaged	Repair
Belly plates Damaged	Replace
Radiator Cradle Damaged	Replace
Jack Missing	Replace
Wheel Spanner Missing	Replace
Triangle Missing	Replace
Warning light illuminated on dashboard	Repair
Vehicle license disk missing only operator card	Replace
Radiator and Aircon condenser misaligned.	Repair

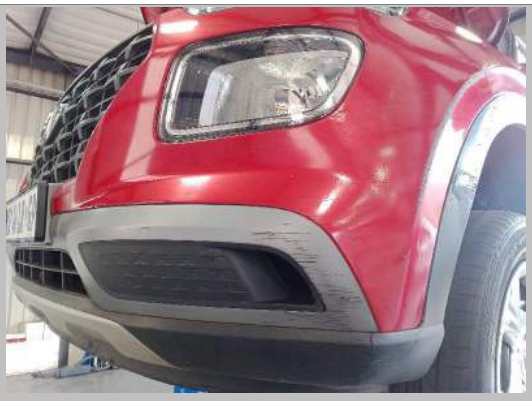
Front Bumper

General Comments: ACCORDING TO THE AGE AND MILEAGE OF THE VEHICLE, NORMAL WEAR AND TEAR MARKS ARE VISIBLE ON THE INTERIOR, EXTERIOR, ELECTRICAL AND MECHANICAL PARTS.VEHICLE INTERIOR DIRTY AND PANELS SCRATCHED / POOR RESIDUAL TRACES OF REPAIR ON BODY PANELS / BODY PANELS MISALIGNED / STONE CHIPS AND SPRAY WORK ON BODY PANELS / DENTS AND SCRATCHES ON BODY PANELS / SIGNS OF IMPACT DAMAGE TO FRONT OF VEHICLE.
