CONDITION REPORT

Report No:
2017314573
DATE
20/10/2026

Vehicle Type	PASSENGER VEHICLE	Registered Owner	
Manufacturer	HYUNDAI	Registration Number	HKJ473L
Model	VENUE 1.2 61KW MPI MOTION [2022-2024]	Register Number	
VIN	MALFB81BLPM405619	Date Of First Licensing	
Engine Number		Last COR	
Doors	5	License Expiry Date	30/04/2027
Color	SILVER	Power / Displacement	
Year Model	2023	Paint Finish	TWO COAT UNI
Km Reading	98,795 KM	Fuel	PETROL
Cab / Body Type	HATCHBACK	Transmission	MANUAL

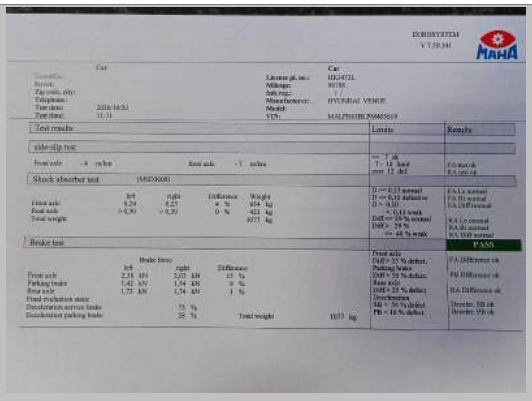
Brake and shock absorber repor

Left	Right		
	Braking Force [KN]	Braking Force [KN]	Axle Weight [KG]	Deceleration [m/s²]
Front	2.38	2.03	-	
Rear	1.73	1.74	-	
Emergency / Parking	1.42	1.54	-

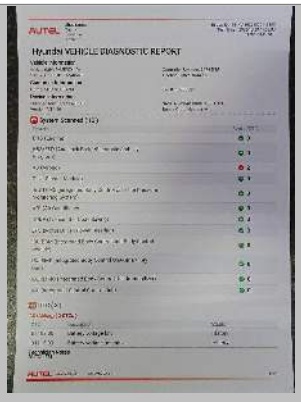
Diagnostic report page 1

No	System	Code	Description	Status
1	AB(AIRBAG)	B1102:00	BATTERY VOLTAGE LOW

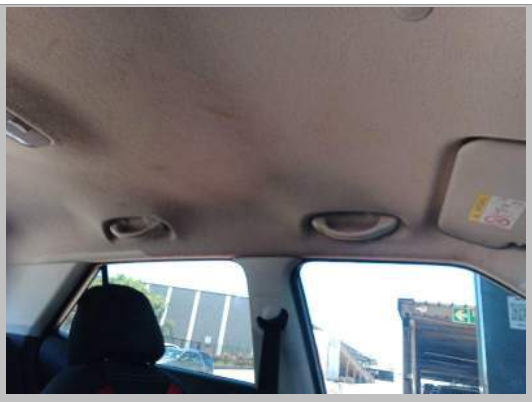
Damage	Repair Way
Seat Rear Damaged	Repair
Hood Lining Dirty	Repair
Door Sealing Rubber Front Left Excessive Wear & Tear	Replace
Door Sealing Rubber Front Right Damaged	Replace
Boot Carpet Damaged	Repair
Front Bumper Paintwork • Scratched	Repair
Bonnet Dented	Repair
Door Front Right Paintwork • Scratched	Repair
Door Rear Left Damaged	Repair
Windscreen Cracked	Replace
Spare Tyre Damaged	Replace
Rim Spare Wheel Dented	Repair
Belly plates Damaged	Repair
Fuel Tank Sweat	Replace
