CONDITION REPORT

Report No:
2017317132
DATE
26/10/2026

Vehicle Type	PASSENGER VEHICLE	Registered Owner	MFC
Manufacturer	HYUNDAI	Registration Number	MF27GGGP
Model	VENUE	Register Number	
VIN	MALFB81BLSM612604	Date Of First Licensing	
Engine Number		Last COR	
Doors	5	License Expiry Date	28/02/2027
Color	WHITE	Power / Displacement	
Year Model		Paint Finish	TWO COAT METALLIC
Km Reading	16,704 KM	Fuel	PETROL
Cab / Body Type	HATCHBACK	Transmission	MANUAL

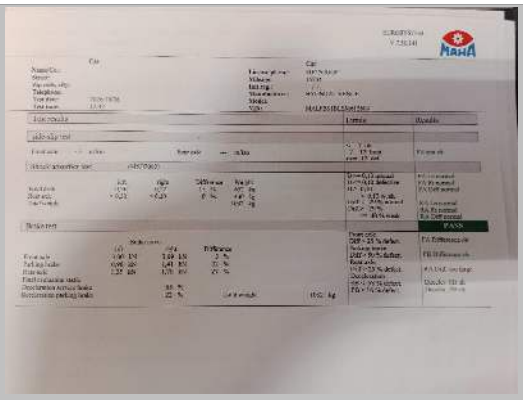
Brake test.

Brake Test Results

Left	Right		
	Braking Force [KN]	Braking Force [KN]	Axle Weight [KG]	Deceleration [m/s²]
Front	3.0	3.09	-	
Rear	1.25	1.7	-	
Emergency / Parking	0.96	1.41	-

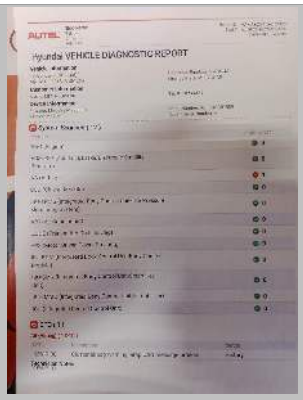
Diagnostic.

During the diagnostic no active error messages were detected. (See also attached Diagnostic Report. For more information regarding the Fault Codes (DTC) and the recommended rectifications please contact the workshops of the vehicle manufacture).

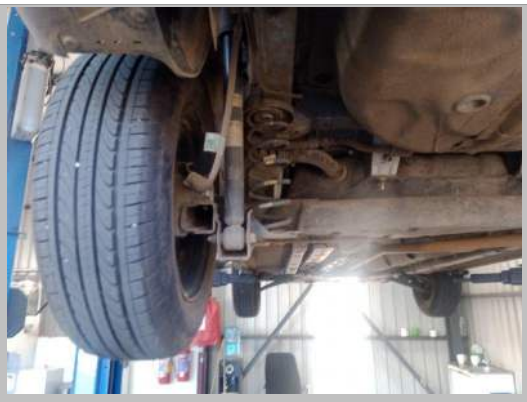
LF TYRE TREAD

Size	Load/Speed Index	Manufacture	Model	Type*	Production Date	Tread Depth (mm)
Front Left	195/65R15	91H	Goodyear	Assurance	V	1924	2 mm
Front Right	195/65R15	91H	Goodyear	Assurance	V	1824	2 mm
Rear Left	195/65R15	91H	Goodyear	Assurance	V	1924	2 mm
Rear Right	195/65R15	91H	Goodyear	Assurance	V	1924	2 mm
Spare	195/65R15	91H	Goodyear	Assurance	V	1824	1 mm
