CONDITION REPORT

Report No:
2017314067
DATE
19/10/2026

Vehicle Type	PASSENGER VEHICLE	Registered Owner	
Manufacturer	HYUNDAI	Registration Number	MN15XGGP
Model	GRAND CRETA 2.0 ELITE AT [2022-2026]	Register Number	
VIN	MALPC815MPM835280	Date Of First Licensing	
Engine Number		Last COR	
Doors	5	License Expiry Date	31/08/2027
Color	BLUE	Power / Displacement	
Year Model	2023	Paint Finish	TWO COAT UNI
Km Reading	25,286 KM	Fuel	PETROL
Cab / Body Type	HATCHBACK	Transmission	AUTOMATIC

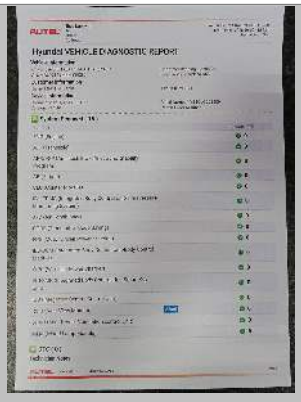
Diagnostic report page 1

During the diagnostic no active error messages were detected. (See also attached Diagnostic Report. For more information regarding the Fault Codes (DTC) and the recommended rectifications please contact the workshops of the vehicle manufacture).

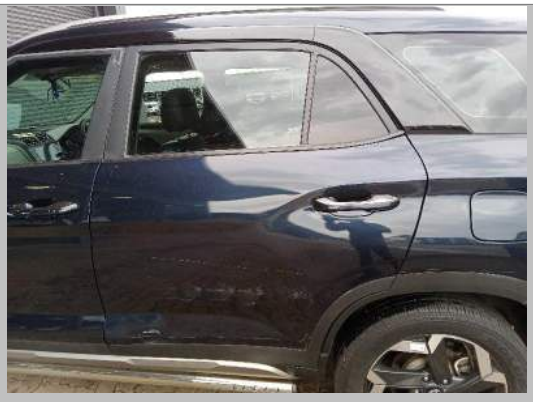
Damage	Repair Way
Center Console / Cubbyhole + Lid Defective	Repair
Switch Electrical Window Winder rear right Damaged	Replace
Tail Light Left Cracked	Replace
Headlight Right Damaged	Replace
Boot Carpet Damaged	Repair
Front Bumper Damaged	Repair
Bonnet Residual Traces of Repair	Repair
Front Fender Left Residual Traces of Repair	Repair
Front Fender Right Residual Traces of Repair	Repair
Rear Fender Left Damaged	Repair
Rear Fender Right Residual Traces of Repair	Repair
Door Front Left Residual Traces of Repair	Repair
Door Front Right Residual Traces of Repair	Repair
Door Rear Left Damaged	Repair
Door Rear Right Residual Traces of Repair	Repair
Boot Lid / Hatch door Residual Traces of Repair	Repair
Rear bumper Damaged	Repair
Rocker Panel Left Paintwork • Scratched	Repair
Windscreen Chipped	Repair
Tyre Front Right Damaged	Replace
Tyre Rear Left Damaged	Replace
Rim Front Right Scratched	Repair
Chassis Damaged	Repair
