# CONDITION REPORT

**Report No:**
**2017317349**
**DATE**
**26/10/2026**

| Model | SWIFT 1.2I GL 5-DR AT [2018-2021] | Register Number | |
| VIN | MBHCZC63S00391462 | Date Of First Licensing | |

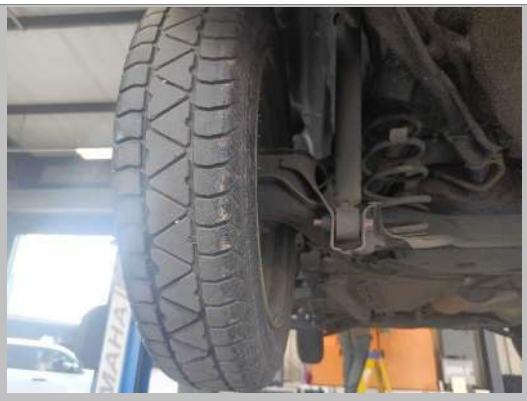
LR TYRE TREAD

| Damage | Repair Way |
|---|---|
| Rear tyres size differs | Replace |

| | Size | Load/Speed Index | Manufacture | Model | Type* | Production Date | Tread Depth (mm) |
|---|---|---|---|---|---|---|---|
| **Rear Left** | T135/70R15 | 99M | STAR XT | TEMPORARY | V | 1019 | 5 mm |
