CONDITION REPORT

Report No:
2017316614
DATE
23/10/2026

Vehicle Type	PASSENGER VEHICLE	Registered Owner	
Manufacturer	SUZUKI	Registration Number	KT75YPGP
Model	SWIFT 1.2I GA 5-DR [2021-2025]	Register Number	
VIN	MBHCZC63S00A21310	Date Of First Licensing	
Engine Number		Last COR	
Doors	5	License Expiry Date	31/05/2027
Color	SILVER	Power / Displacement	
Year Model	2022	Paint Finish	TWO COAT UNI
Km Reading	79,413 KM	Fuel	PETROL
Cab / Body Type	HATCHBACK	Transmission	MANUAL

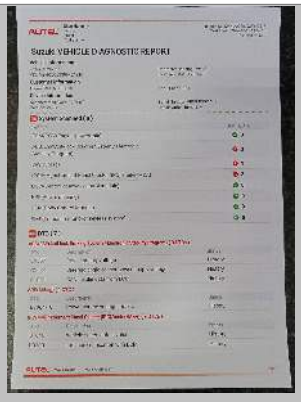
Diagnostic report page 1

No	System	Code	Description	Status
1	ABS/ESP(ANTI-LOCK BRAKING SYSTEM/ELECTRONIC STABIL	C1057	POWER SUPPLY VOLTAGE

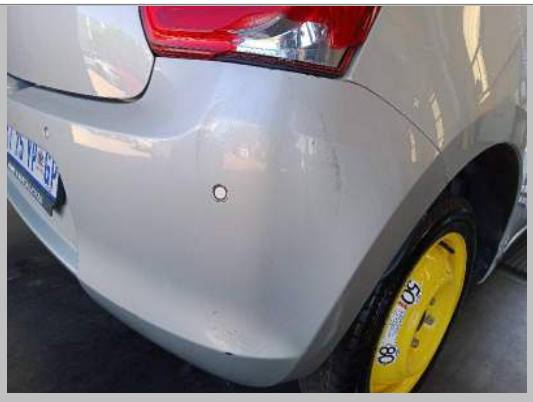
Damage	Repair Way
Engine Oil Sweat	Repair
Battery box Damaged	Replace
Air cleaner Defective	Repair
Bonnet hinges Damaged	Replace
Bonnet stay and shocks Missing	Replace
Central Air Vent Damaged	Replace
Radio/CD/USB Missing	Replace
Air Conditioner Insufficient	Replace
Tail Light Left Cracked	Replace
Tail Light Right Damaged	Replace
Headlight Left Damaged	Replace
Seat Front Right Damaged	Repair
Parcel Tray Damaged	Replace
Side Mirror Right Residual Traces of Repair	Repair
Front Bumper Damaged	Replace
Grill Cracked	Replace
Bonnet Damaged	Repair
Bonnet slam plate (Shock tower/ Inner tray) Damaged	Replace
A • Pillar Right Residual Traces of Repair	Repair
B • Pillar Left Dented	Repair
Front Fender Left Damaged	Repair
Rear Fender Left Damaged	Repair
Rear Fender Right Paintwork • Scratched	Repair
Front Fender Left / Inner Tray Damaged	Repair
Front Fender Right / Inner Tray Damaged	Replace
Door Front Left Damaged	Repair
Door Front Right Damaged	Repair
