CONDITION REPORT

Report No:
2017315694
DATE
22/10/2026

Vehicle Type	PASSENGER VEHICLE	Registered Owner	MFC AUCTION HOUSE
Manufacturer	SUZUKI	Registration Number	KV11GWGP
Model	SWIFT 1.2I GA 5-DR [2021-2025]	Register Number	
VIN	MBHCZC63S00A54871	Date Of First Licensing	
Engine Number		Last COR	
Doors	5	License Expiry Date	30/04/2027
Color	WHITE	Power / Displacement	
Year Model	2022	Paint Finish	M - METALLIC
Km Reading	266,427 KM	Fuel	PETROL
Cab / Body Type	HATCHBACK	Transmission	MANUAL

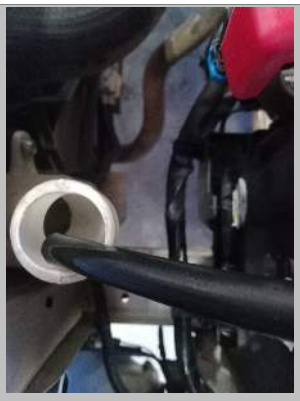
Damage	Repair Way
Engine Oil Sweat	Repair
Central Air Vent Damaged	Repair
Tail Light Right Cracked	Replace
Front Bumper Paintwork • Scratched	Repair
Bonnet Paintwork • Chipmarks	Repair
Front Fender Left Residual Traces of Repair	Repair
Front Fender Right Residual Traces of Repair	Repair
Rear Fender Left Dented	Repair
Rear Fender Right Paintwork • Scratched	Repair
Door Front Left Dented	Repair
Door Front Right Dented	Repair
Door Rear Left Paintwork • Scratched	Repair
Door Rear Right Paintwork • Scratched	Repair
Boot Lid / Hatch door Paintwork • Scratched	Repair
Rear bumper Damaged	Repair
Fuel Flap Defective	Repair
Windscreen Cracked	Replace
Rim Front Right Dented	Repair
Gearbox Oil Leak	Repair
Radiator Cradle Dented	Repair
Clutch Operation Insufficient	Repair
Body exterior	Vehicle got minor scratches, stone chips and dents
Body exterior	Signs of spray work done on some body panels
Both front fender liner missing	Replace
