CONDITION REPORT

Report No:
2017316381
DATE
23/10/2026

Vehicle Type	PASSENGER VEHICLE	Registered Owner	MFC AUCTION HOUSE
Manufacturer	SUZUKI	Registration Number	LF73VGGP
Model	SWIFT 1.2I GA 5-DR [2021-2025]	Register Number	
VIN	MBHCZC63S00C14115	Date Of First Licensing	
Engine Number		Last COR	
Doors	5	License Expiry Date	
Color	WHITE	Power / Displacement	
Year Model	2023	Paint Finish	TWO COAT UNI
Km Reading	58,405 KM	Fuel	PETROL
Cab / Body Type	HATCHBACK	Transmission	MANUAL

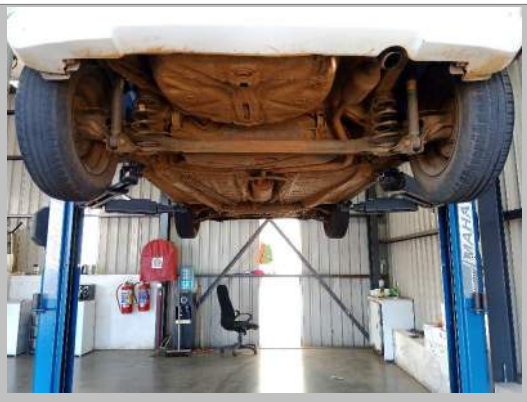
Undercarriage front.

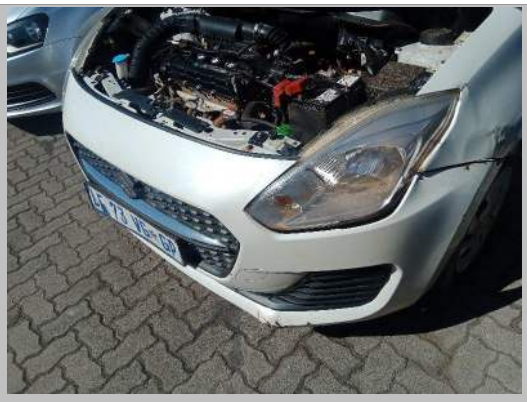
Damage	Repair Way
Radio/CD/USB Damaged	Replace
Center Console / Cubbyhole + Lid Damaged	Replace
Tail Light Left Damaged	Replace
Headlight Left Damaged	Replace
Seat Front Right Damaged	Replace
Front Bumper Damaged	Repair
Bonnet Damaged	Repair
Front Fender Left Damaged	Repair
Front Fender Right Damaged	Repair
Rear Fender Left Damaged	Repair
Door Front Left Damaged	Repair
Door Front Right Damaged	Repair
Door Rear Left Damaged	Repair
Door Rear Right Damaged	Repair
Doorstopper Front Right Damaged	Replace
Boot Lid / Hatch door Damaged	Repair
Rear bumper Damaged	Repair
Roof Damaged	Repair
Windscreen Damaged	Replace
Tyre Rear Left Worn	Replace
Sub Frame Deformed	Repair
Radiator Cross Member Damaged	Replace
Airbag warning lights illuminated	repair
License disc missing	report
