CONDITION REPORT

Report No:
2017315456
DATE
21/10/2026

Vehicle Type	PASSENGER VEHICLE	Registered Owner	MFC AUCTION HOUSE
Manufacturer	SUZUKI	Registration Number	LW14WKGP
Model	SWIFT 1.2I GA 5-DR [2021-2025]	Register Number	
VIN	MBHCZC63S00E09902	Date Of First Licensing	
Engine Number		Last COR	
Doors	5	License Expiry Date	31/07/2026
Color	WHITE	Power / Displacement	
Year Model	2024	Paint Finish	M - METALLIC
Km Reading	82,571 KM	Fuel	PETROL
Cab / Body Type	HATCHBACK	Transmission	MANUAL

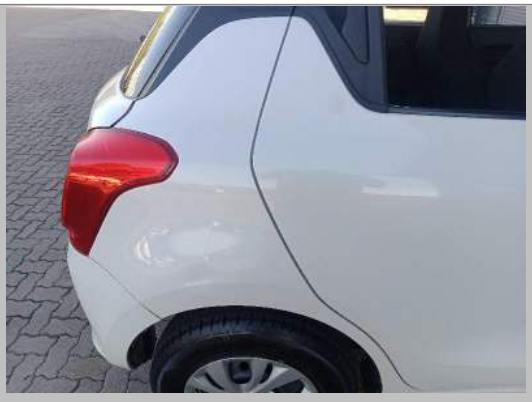
Damage	Repair Way
Engine Oil Sweat	Repair
Tail Light Left Damaged	Replace
Front Bumper Paintwork • Scratched	Repair
Front Fender Left Dented	Repair
Front Fender Right Dented	Repair
Rear Fender Left Residual Traces of Repair	Repair
Rear Fender Right Dented	Repair
Rear Fender Left / Inner Tray Residual Traces of Repair	Repair
Door Front Left Paintwork • Scratched	Repair
Door Front Right Paintwork • Scratched	Repair
Door Rear Left Paintwork • Scratched	Repair
Door Rear Right Paintwork • Scratched	Repair
Boot Lid / Hatch door Residual Traces of Repair	Repair
Rear bumper Residual Traces of Repair	Repair
Inner Boot Floor Pan and Spare Wheel Well Residual Traces of Repair	Repair
Windscreen Cracked	Replace
Tyre Front Left Smooth	Replace
Radiator Cradle Dented	Repair
Body exterior	Vehicle got some scratches, stone chips and dents
Body exterior	Signs of spray work done on some body panels
L/R tire deferred name brand and size	Repair
